# Access Compliance Report

## Public Rights-of-Way

| Intersection ID: 7131 | Main Street: N_TRYON_ST | Cross Street: ORCHARD_TRACE_LN | Location: NW |
| ADA ID: C995D0DFFDA1 | Ramp Type: Directional1 | Initial Pass/Fail: Pass | Overall Compliance: No |

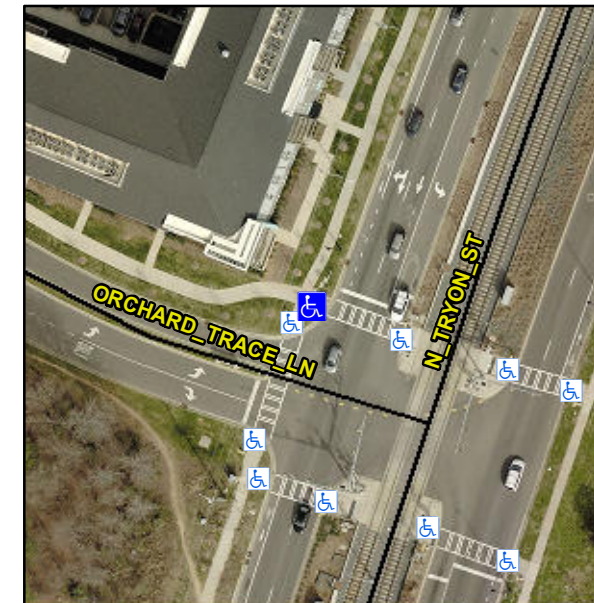
**R305.2, R304.5.4**

| Compliance | Description | Data | Compliance | Description | Data |
|---|---|---|---|---|---|
| N/A | Landing Curb? (Y/N) | N/A | No | DWS Offset LT (in) | 17.0 |
| Yes | Gutter Ponding? | No | No | Gutter Slope (%) | 6.3 |

**Remove & Replace Detectable Warning System. Remove & Replace Gutter.**
