# Access Compliance Report

## Public Rights-of-Way

### (Curb Ramps)

Intersection ID: 2576	Main Street: CAMBRIDGE_BAY_DR	Cross Street: WHISTLER'S_CHASE_DR	Location: E
ADA ID: C995D432783C	Ramp Type: PerpDiag	Initial Pass/Fail: Fail	Overall Compliance: No
Severity Score: 21.25			
Codes/Mitigation Info/Possible Solution		Field Measurements/Component Compliance

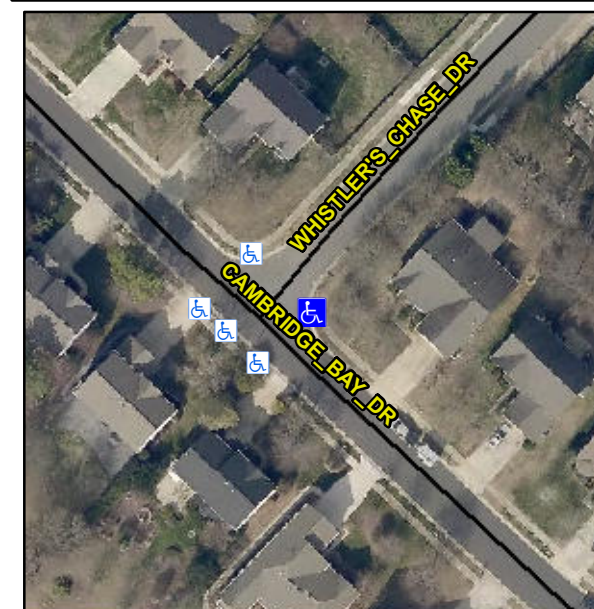
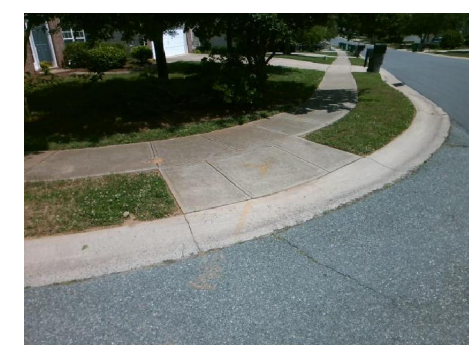
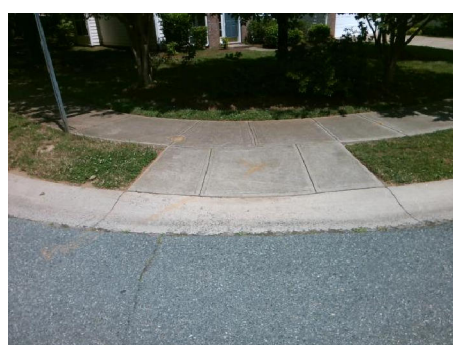
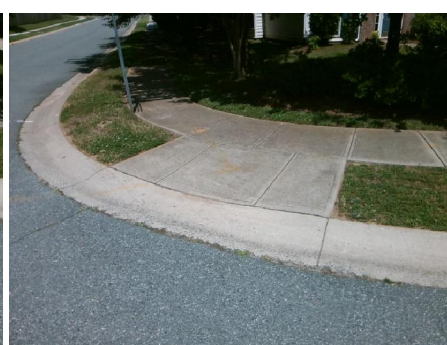
**Not Found, R304.5.1, R304.2.2**

Compliance	Description	Data	Compliance	Description	Data
N/A	Ramp Length (in)	48.0	No	Ramp Slope (%)	10.3
No	Ramp Width (in)	44.0	Yes	Ramp XSlope (%)	1.3
N/A	Flare Type LT	N/A	N/A	Flare Type RT	N/A
N/A	Flare Slope LT (%)	N/A	N/A	Flare Slope RT (%)	N/A
N/A	Flare Traversable LT?	N/A	N/A	Flare Traversable RT?	N/A
N/A	Landing Length (in)	N/A	N/A	DWS Provided?	N/A
N/A	Landing Width (in)	N/A	N/A	DWS Contrast?	N/A
N/A	Landing Slope (%)	N/A	N/A	DWS Length (in)	N/A
N/A	Landing X Slope (%)	N/A	N/A	DWS Full Width?	N/A
N/A	Landing Curb? (Y/N)	N/A	N/A	DWS Offset (in)	N/A
N/A	Shared Landing?	N/A			
N/A	Gutter Ponding?	N/A	N/A	Gutter Slope (%)	N/A
N/A	Gutter Lip Ht (in)	N/A	N/A	Gutter X Slope (%)	N/A
N/A	Painted X Walk1?	No	N/A	Painted X Walk2?	No
	X Walk 1 Direction	To NW		X Walk 2 Direction	To SW
N/A	X Walk 1 Width (in)	N/A	N/A	X Walk 2 Width (in)	N/A
	X Walk 1 Slope (%)	4.5		X Walk 2 Slope (%)	3.7
	X Walk 1 X Slope (%)	3.8		X Walk 2 X Slope (%)	7.2

N/A	Ramp inside XWalk1?	N/A	N/A	Ramp inside XWalk2?	N/A
	Road Slope (%)	1.3	N/A	Clear Space?	N/A
	Road X Slope (%)	6.2	N/A	Clear Space to XWalk (in)	N/A
N/A	Any Obstructions?	N/A	N/A	Storm Grate/Utility Hazard?	N/A
	Obstruction Type			Storm Grate/Utility Type	
		N/A			N/A
		Yes		Surface Condition? (G/P)	Good

**Remove & Replace Curb Ramp With Two New Directional Ramps or Equivalent.**
