Access Compliance Report Public Rights-of-Way (Curb Ramps)

Intersection ID: 10090	Main Street: ROSLYN_AV	Cross Street: S_TURNER_AV	Location: S
ADA ID: C9A9A41D178B	Ramp Type: Perp	Initial Pass/Fail: Fail	Overall Compliance: No Severity Score: 8.75

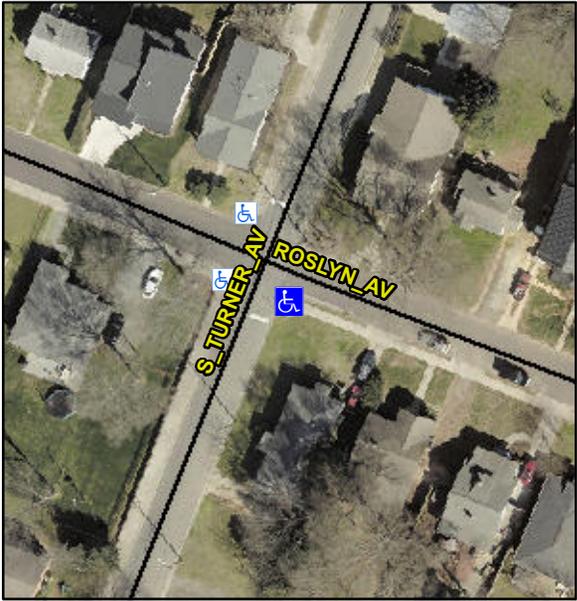
PROW/ADA:
Not Found, R304.5.1

Compliance	Description	Data	Compliance	Description	Data
N/A	Ramp Length (in)	86.0	Yes	Ramp Slope (%)	5.0
No	Ramp Width (in)	45.5	Yes	Ramp XSlope (%)	1.2
N/A	Flare Type LT	N/A	N/A	Flare Type RT	N/A
N/A	Flare Slope LT (%)	N/A	N/A	Flare Slope RT (%)	N/A
N/A	Flare Traversable LT?	N/A	N/A	Flare Traversable RT?	N/A
N/A	Landing Length (in)	N/A	N/A	DWS Provided?	N/A
N/A	Landing Width (in)	N/A	N/A	DWS Contrast?	N/A
N/A	Landing Slope (%)	N/A	N/A	DWS Length (in)	N/A
N/A	Landing X Slope (%)	N/A	N/A	DWS Full Width?	N/A
N/A	Landing Curb? (Y/N)	N/A	N/A	DWS Offset (in)	N/A
N/A	Shared Landing?	N/A			
N/A	Gutter Ponding?	N/A	N/A	Gutter Slope (%)	N/A
N/A	Gutter Lip Ht (in)	N/A	N/A	Gutter X Slope (%)	N/A
N/A	Painted X Walk1?	No	N/A	Painted X Walk2?	N/A
	X Walk 1 Direction	To NW		X Walk 2 Direction	N/A
N/A	X Walk 1 Width (in)	N/A	N/A	X Walk 2 Width (in)	N/A
	X Walk 1 Slope (%)	0.1		X Walk 2 Slope (%)	N/A
	X Walk 1 X Slope (%)	1.5		X Walk 2 X Slope (%)	N/A

N/A	Ramp inside XWalk1?	N/A	N/A	Ramp inside XWalk2?	N/A
	Road Slope (%)	N/A	N/A	Clear Space?	N/A
	Road X Slope (%)	N/A	N/A	Clear Space to XWalk (in)	N/A
N/A	Any Obstructions?	N/A	N/A	Storm Grate/Utility Hazard?	N/A
	Obstruction Type			Storm Grate/Utility Type	
			N/A		N/A
			Yes	Surface Condition? (G/P)	Good

Possible Solutions:
Remove & Replace Entire Ramp.
