# Access Compliance Report

## Public Rights-of-Way

| Intersection ID: 31883 | Main Street: CENTERLINE_DR | Cross Street: SPRUCE_PEAK_RD | Location: SE |
| ADA ID: C9A9C79349BC | Ramp Type: PerpDiag | Initial Pass/Fail: Fail | Overall Compliance: No |

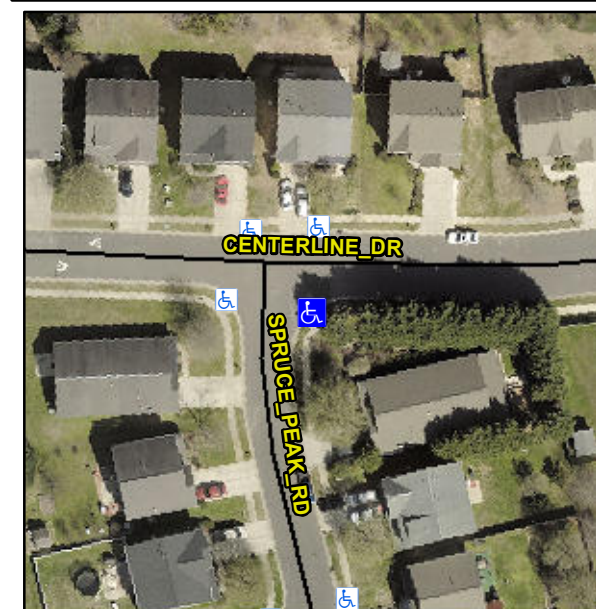
| Severity Score: 33.75 | | | |

| Compliance | Description | Data | Compliance | Description | Data |
|---|---|---|---|---|---|
| N/A | Ramp Length (in) | 49.0 | Yes | Ramp Slope (%) | 5.0 |
| No | Ramp Width (in) | 36.0 | No | Ramp XSlope (%) | 7.8 |

Possible Solutions:

**Remove & Replace Curb Ramp With Two New Directional Ramps or Equivalent.**

PROW/ADA:

**R304.5.1, R304.5.3**

Total Cost: \$ 3200.00
