Access Compliance Report

Public Rights-of-Way

(Curb Ramps)

Intersection ID: 28449	Main Street: LAURENFIELD_DR	Cross Street: SUMMER_CREEK_LN	Location: SW
ADA ID: C9B6AC126745	Ramp Type: BlendTrans1	Initial Pass/Fail: Fail	Overall Compliance: No
		Severity Score: 1.25

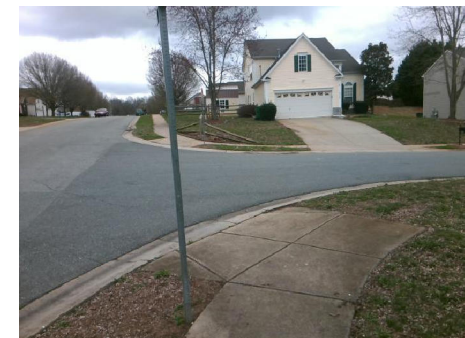
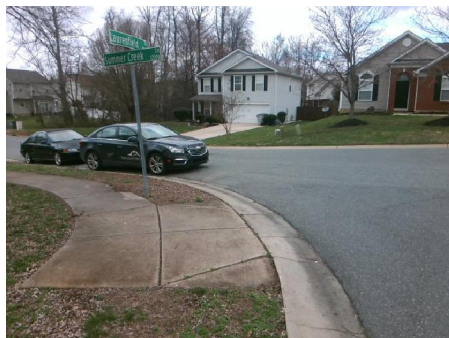
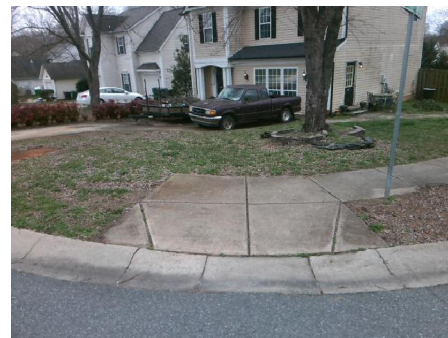
Compliance	Description	Data	Compliance	Description	Data
N/A	Ramp Length (in)	50.5	Yes	BlendTrans Slope (%)	3.9
Yes	Ramp Width (in)	76.0	No	BlendTrans XSlope (%)	2.3
N/A	Flare Type LT	N/A	N/A	Flare Type RT	N/A
N/A	Flare Slope LT (%)	N/A	N/A	Flare Slope RT (%)	N/A
N/A	Flare Traversable LT?	N/A	N/A	Flare Traversable RT?	N/A
N/A	Landing Length (in)	N/A	N/A	DWS Provided?	N/A
N/A	Landing Width (in)	N/A	N/A	DWS Contrast?	N/A
N/A	Landing Slope (%)	N/A	N/A	DWS Length (in)	N/A
N/A	Landing X Slope (%)	N/A	N/A	DWS Full Width?	N/A
N/A	Landing Curb? (Y/N)	N/A	N/A	DWS Offset (in)	N/A
N/A	Shared Landing?	N/A			
N/A	Gutter Ponding?	N/A	N/A	Gutter Slope (%)	N/A
N/A	Gutter Lip Ht (in)	N/A	N/A	Gutter X Slope (%)	N/A
N/A	Painted X Walk1?	No	N/A	Painted X Walk2?	N/A
	X Walk 1 Direction	To E		X Walk 2 Direction	N/A
	X Walk 1 Width (in)	N/A		X Walk 2 Width (in)	N/A
	X Walk 1 Slope (%)	8.3		X Walk 2 Slope (%)	N/A
	X Walk 1 X Slope (%)	4.2		X Walk 2 X Slope (%)	N/A

N/A	Ramp inside XWalk1?	N/A	N/A	Ramp inside XWalk2?	N/A
	Road Slope (%)	4.2		Clear Space?	N/A
	Road X Slope (%)	8.3	N/A	Clear Space to XWalk (in)	N/A
N/A	Any Obstructions?	N/A	N/A	Storm Grate/Utility Hazard?	N/A
	Obstruction Type			Storm Grate/Utility Type	
		N/A			N/A
			Yes	Surface Condition? (G/P)	Good
			No	Curb Slope (%)	11.7

Remove & Replace Curb Ramp With Two New Directional Ramps or Equivalent.
