Access Compliance Report

Public Rights-of-Way

(Curb Ramps)

Intersection ID: N/A	Main Street: WINSLET_DR	Cross Street: N/A	Location: SE
ADA ID: C9C3D2F3FA4E	Ramp Type: Perp	Initial Pass/Fail: Fail	Overall Compliance: No
Codes/Mitigation Info/Possible Solution		Field Measurements/Component Compliance	
Severity Score: 13.75

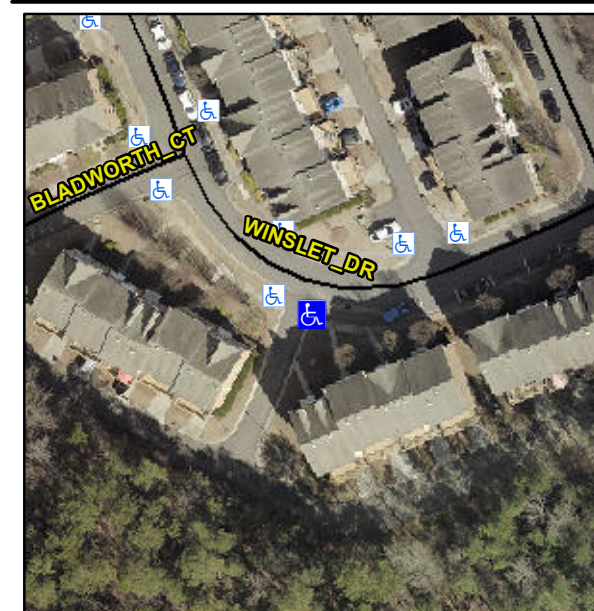
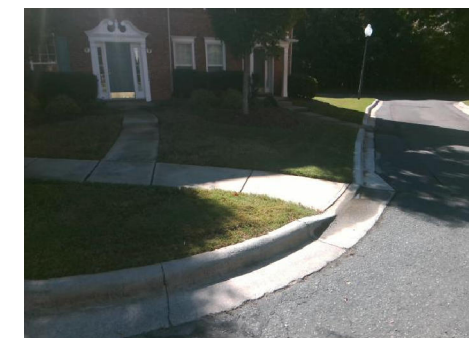
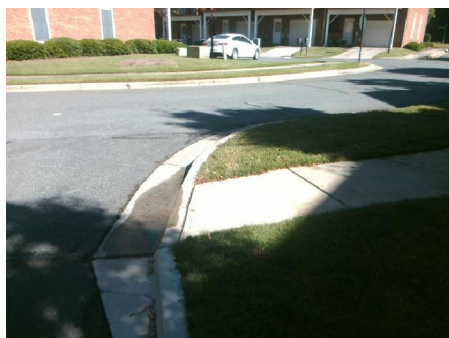
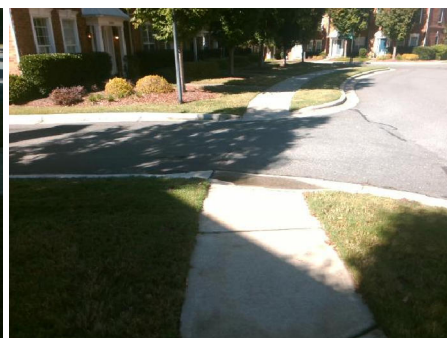
Not Found, R304.2.2, R304.5.3

Compliance	Description	Data	Compliance	Description	Data
N/A	Ramp Length (in)	43.0	No	Ramp Slope (%)	11.7
Yes	Ramp Width (in)	48.0	No	Ramp XSlope (%)	3.3
N/A	Flare Type LT	N/A	N/A	Flare Type RT	N/A
N/A	Flare Slope LT (%)	N/A	N/A	Flare Slope RT (%)	N/A
N/A	Flare Traversable LT?	N/A	N/A	Flare Traversable RT?	N/A
N/A	Landing Length (in)	N/A	N/A	DWS Provided?	N/A
N/A	Landing Width (in)	N/A	N/A	DWS Contrast?	N/A
N/A	Landing Slope (%)	N/A	N/A	DWS Length (in)	N/A
N/A	Landing X Slope (%)	N/A	N/A	DWS Full Width?	N/A
N/A	Landing Curb? (Y/N)	N/A	N/A	DWS Offset (in)	N/A
N/A	Shared Landing?	N/A			
N/A	Gutter Ponding?	N/A	N/A	Gutter Slope (%)	N/A
N/A	Gutter Lip Ht (in)	N/A	N/A	Gutter X Slope (%)	N/A
N/A	Painted X Walk1?	No	N/A	Painted X Walk2?	N/A
	X Walk 1 Direction	To W		X Walk 2 Direction	N/A
N/A	X Walk 1 Width (in)	N/A	N/A	X Walk 2 Width (in)	N/A
	X Walk 1 Slope (%)	0.6		X Walk 2 Slope (%)	N/A
	X Walk 1 X Slope (%)	1.2		X Walk 2 X Slope (%)	N/A

N/A	Ramp inside XWalk1?	N/A	N/A	Ramp inside XWalk2?	N/A
	Road Slope (%)	N/A	N/A	Clear Space?	N/A
	Road X Slope (%)	N/A	N/A	Clear Space to XWalk (in)	N/A
N/A	Any Obstructions?	N/A	N/A	Storm Grate/Utility Hazard?	N/A
	Obstruction Type			Storm Grate/Utility Type	
		N/A			N/A
			Yes	Surface Condition? (G/P)	Good

Remove & Replace Entire Ramp.
