Access Compliance Report

Public Rights-of-Way

(Curb Ramps)

Intersection ID: 23558	Main Street: HAMLIN_PARK_DR	Cross Street: PARK_RD	Location: NW
ADA ID: C9C46ABD6B4B	Ramp Type: BlendTrans1	Initial Pass/Fail: Fail	Overall Compliance: No
		Severity Score: 1.25

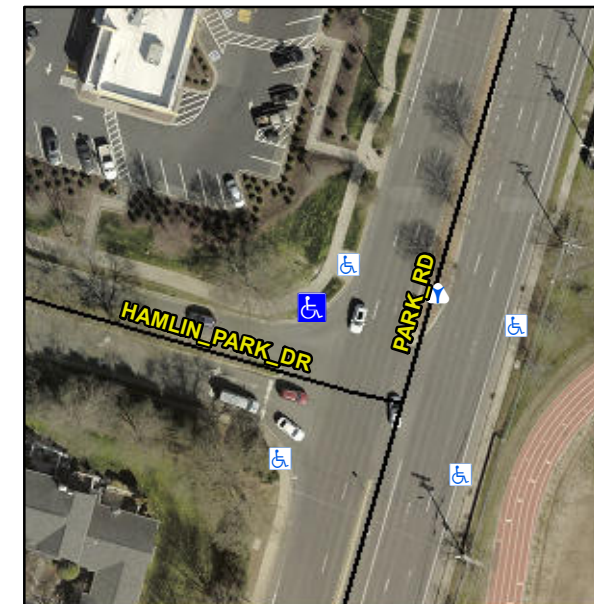
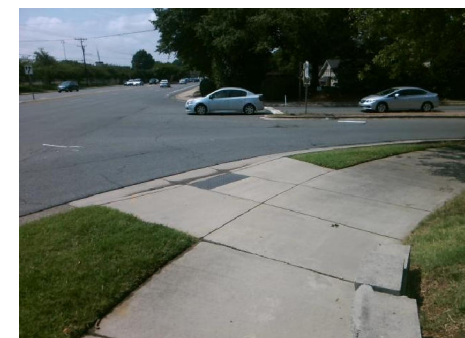
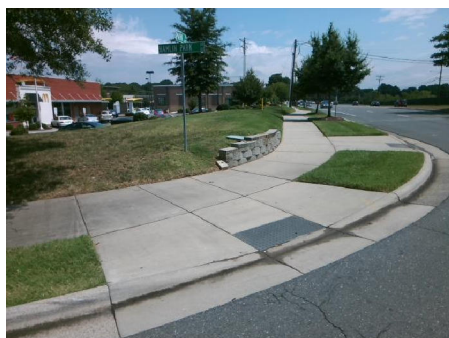
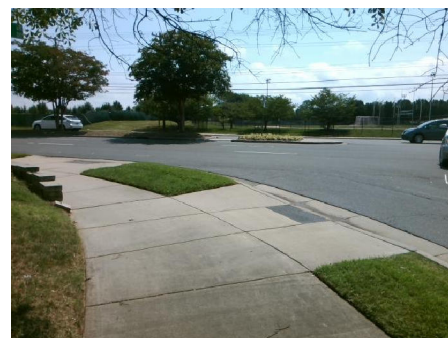
Not Found, R304.5.3

Compliance	Description	Data	Compliance	Description	Data
N/A	Ramp Length (in)	69.0	Yes	BlendTrans Slope (%)	3.4
Yes	Ramp Width (in)	48.0	No	BlendTrans XSlope (%)	2.7
N/A	Flare Type LT	N/A	N/A	Flare Type RT	N/A
N/A	Flare Slope LT (%)	N/A	N/A	Flare Slope RT (%)	N/A
N/A	Flare Traversable LT?	N/A	N/A	Flare Traversable RT?	N/A
N/A	Landing Length (in)	N/A	N/A	DWS Provided?	N/A
N/A	Landing Width (in)	N/A	N/A	DWS Contrast?	N/A
N/A	Landing Slope (%)	N/A	N/A	DWS Length (in)	N/A
N/A	Landing X Slope (%)	N/A	N/A	DWS Full Width?	N/A
N/A	Landing Curb? (Y/N)	N/A	N/A	DWS Offset (in)	N/A
N/A	Shared Landing?	N/A			
N/A	Gutter Ponding?	N/A	N/A	Gutter Slope (%)	N/A
N/A	Gutter Lip Ht (in)	N/A	N/A	Gutter X Slope (%)	N/A
N/A	Painted X Walk1?	No	N/A	Painted X Walk2?	N/A
	X Walk 1 Direction	To SW		X Walk 2 Direction	N/A
	X Walk 1 Width (in)	N/A		X Walk 2 Width (in)	N/A
	X Walk 1 Slope (%)	0.8		X Walk 2 Slope (%)	N/A
	X Walk 1 X Slope (%)	3.6		X Walk 2 X Slope (%)	N/A

N/A	Ramp inside XWalk1?	N/A	N/A	Ramp inside XWalk2?	N/A
	Road Slope (%)	3.6		Clear Space?	N/A
	Road X Slope (%)	0.8	N/A	Clear Space to XWalk (in)	N/A
N/A	Any Obstructions?	N/A	N/A	Storm Grate/Utility Hazard?	N/A
	Obstruction Type			Storm Grate/Utility Type	
		N/A			N/A
			Yes	Surface Condition? (G/P)	Good
			No	Curb Slope (%)	6.2

Possible Solutions:

Remove & Replace Curb Ramp With Two New Directional Ramps or Equivalent.
