Access Compliance Report

Public Rights-of-Way

(Curb Ramps)

Intersection ID: 17663	Main Street: TRANQUIL_AV	Cross Street: WESTFIELD_RD	Location:	N
ADA ID: C9CCD52C813B	Ramp Type: PerpDiag	Initial Pass/Fail: Fail	Overall Compliance: No	Severity Score: 35
Codes/Mitigation Info/Possible Solution		Field Measurements/Component Compliance

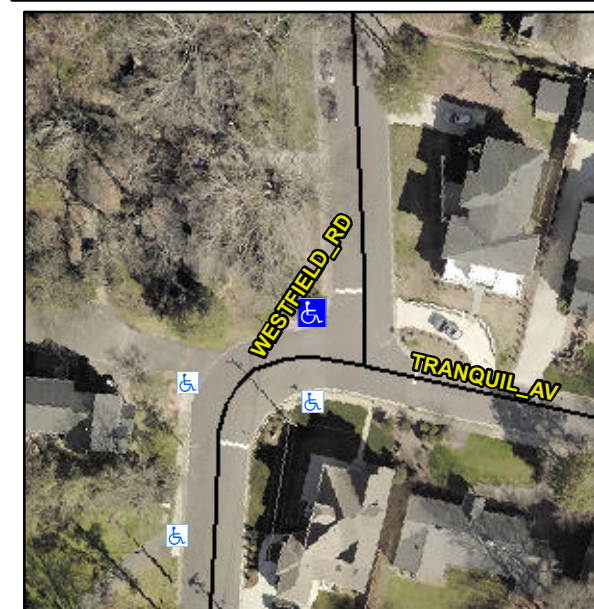
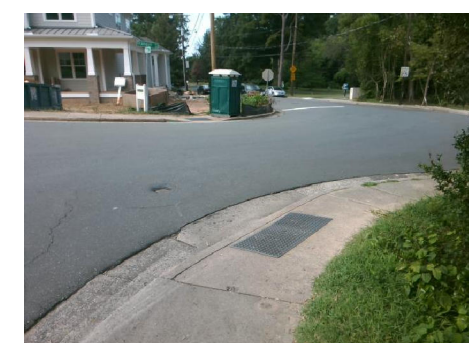
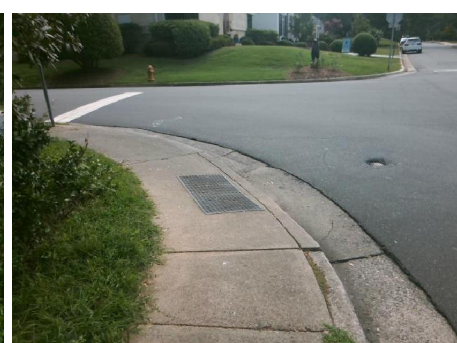
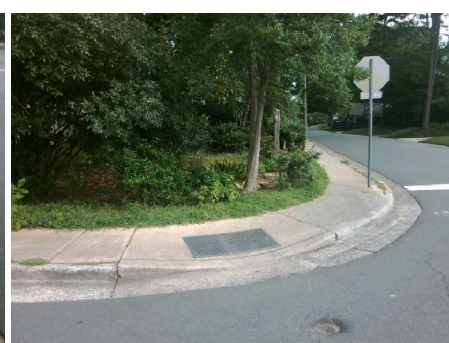
Not Found, R304.5.1, R304.2.2, R304.5.3

Compliance	Description	Data	Compliance	Description	Data
N/A	Ramp Length (in)	48.0	No	Ramp Slope (%)	12.6
No	Ramp Width (in)	38.0	No	Ramp XSlope (%)	3.6
N/A	Flare Type LT	N/A	N/A	Flare Type RT	N/A
N/A	Flare Slope LT (%)	N/A	N/A	Flare Slope RT (%)	N/A
N/A	Flare Traversable LT?	N/A	N/A	Flare Traversable RT?	N/A
N/A	Landing Length (in)	N/A	N/A	DWS Provided?	N/A
N/A	Landing Width (in)	N/A	N/A	DWS Contrast?	N/A
N/A	Landing Slope (%)	N/A	N/A	DWS Length (in)	N/A
N/A	Landing X Slope (%)	N/A	N/A	DWS Full Width?	N/A
N/A	Landing Curb? (Y/N)	N/A	N/A	DWS Offset (in)	N/A
N/A	Shared Landing?	N/A			
N/A	Gutter Ponding?	N/A	N/A	Gutter Slope (%)	N/A
N/A	Gutter Lip Ht (in)	N/A	N/A	Gutter X Slope (%)	N/A
N/A	Painted X Walk1?	No	N/A	Painted X Walk2?	No
	X Walk 1 Direction	To S		X Walk 2 Direction	To E
N/A	X Walk 1 Width (in)	N/A	N/A	X Walk 2 Width (in)	N/A
	X Walk 1 Slope (%)	6.7		X Walk 2 Slope (%)	9.5
	X Walk 1 X Slope (%)	5.6		X Walk 2 X Slope (%)	4.2

N/A	Ramp inside XWalk1?	N/A	N/A	Ramp inside XWalk2?	N/A
	Road Slope (%)	12.9	N/A	Clear Space?	N/A
	Road X Slope (%)	0.2	N/A	Clear Space to XWalk (in)	N/A
N/A	Any Obstructions?	N/A	N/A	Storm Grate/Utility Hazard?	N/A
	Obstruction Type			Storm Grate/Utility Type	
		N/A			N/A
			Yes	Surface Condition? (G/P)	Good

Possible Solutions:

Remove & Replace Curb Ramp With Two New Directional Ramps or Equivalent.
