Access Compliance Report

Public Rights-of-Way

(Curb Ramps)

Intersection ID: 52718	Main Street: AGAVA_LN	Cross Street: MAIDENHAIR_CT	Location:	E
ADA ID: C9D7F36A4201	Ramp Type: Perp	Initial Pass/Fail: Fail	Overall Compliance: No	Severity Score: 10
Codes/Mitigation Info/Possible Solution		Field Measurements/Component Compliance

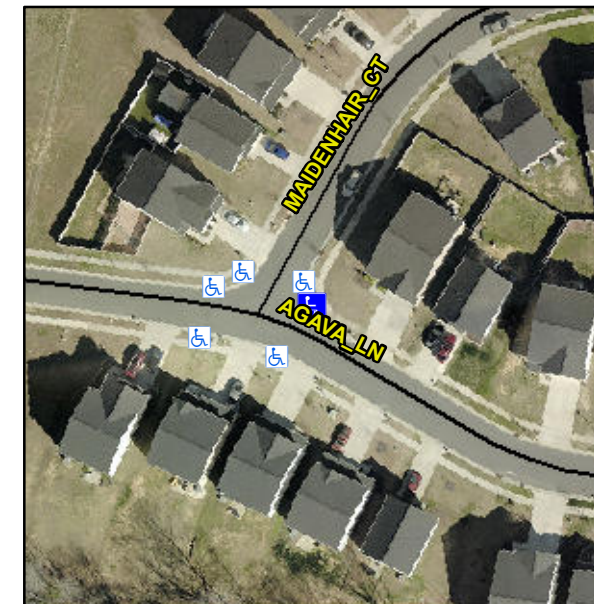
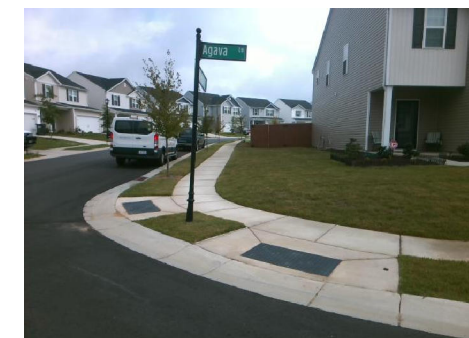
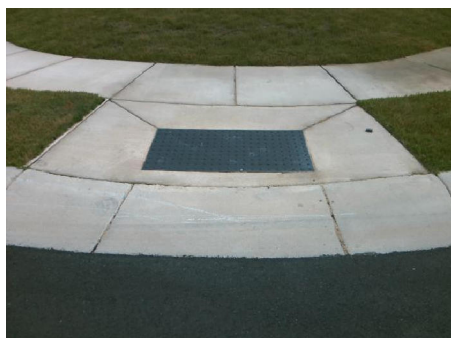
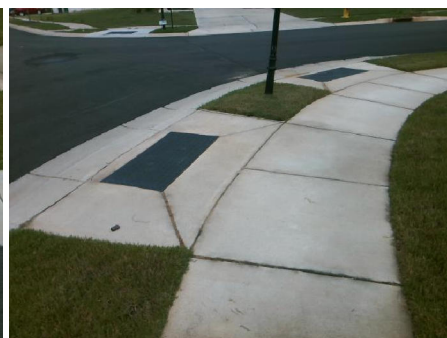
Not Found, R304.5.1, R304.5.3

Compliance	Description	Data	Compliance	Description	Data
N/A	Ramp Length (in)	48.5	Yes	Ramp Slope (%)	5.0
No	Ramp Width (in)	47.0	No	Ramp XSlope (%)	3.2
N/A	Flare Type LT	N/A	N/A	Flare Type RT	N/A
N/A	Flare Slope LT (%)	N/A	N/A	Flare Slope RT (%)	N/A
N/A	Flare Traversable LT?	N/A	N/A	Flare Traversable RT?	N/A
N/A	Landing Length (in)	N/A	N/A	DWS Provided?	N/A
N/A	Landing Width (in)	N/A	N/A	DWS Contrast?	N/A
N/A	Landing Slope (%)	N/A	N/A	DWS Length (in)	N/A
N/A	Landing X Slope (%)	N/A	N/A	DWS Full Width?	N/A
N/A	Landing Curb? (Y/N)	N/A	N/A	DWS Offset (in)	N/A
N/A	Shared Landing?	N/A			
N/A	Gutter Ponding?	N/A	N/A	Gutter Slope (%)	N/A
N/A	Gutter Lip Ht (in)	N/A	N/A	Gutter X Slope (%)	N/A
N/A	Painted X Walk1?	No	N/A	Painted X Walk2?	N/A
	X Walk 1 Direction	To SW		X Walk 2 Direction	N/A
N/A	X Walk 1 Width (in)	N/A	N/A	X Walk 2 Width (in)	N/A
	X Walk 1 Slope (%)	0.3		X Walk 2 Slope (%)	N/A
	X Walk 1 X Slope (%)	2.6		X Walk 2 X Slope (%)	N/A

N/A	Ramp inside XWalk1?	N/A	N/A	Ramp inside XWalk2?	N/A
	Road Slope (%)	N/A	N/A	Clear Space?	N/A
	Road X Slope (%)	N/A	N/A	Clear Space to XWalk (in)	N/A
N/A	Any Obstructions?	N/A	N/A	Storm Grate/Utility Hazard?	N/A
	Obstruction Type			Storm Grate/Utility Type	
		N/A			N/A
			Yes	Surface Condition? (G/P)	Good

Remove & Replace Entire Ramp.
