# Access Compliance Report

## Public Rights-of-Way (Curb Ramps)

Intersection ID: 47664	Main Street: ELM_BEND_DR	Cross Street: WRIGLEY_DR	Location: SW
ADA ID: C9E3693BEF0A	Ramp Type: PerpDiag	Initial Pass/Fail: Fail	Overall Compliance: No
		Severity Score: 8.75

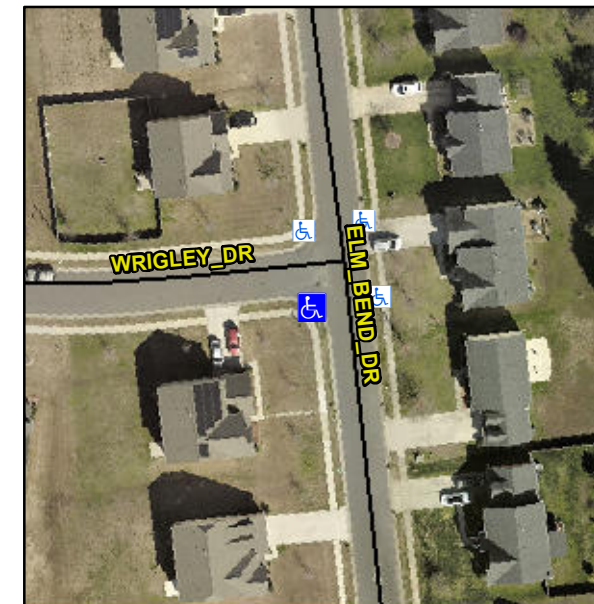
Compliance	Description	Data	Compliance	Description	Data
N/A	Ramp Length (in)	47.0	Yes	Ramp Slope (%)	5.2
No	Ramp Width (in)	46.5	Yes	Ramp XSlope (%)	1.8
N/A	Flare Type LT	N/A	N/A	Flare Type RT	N/A
N/A	Flare Slope LT (%)	N/A	N/A	Flare Slope RT (%)	N/A
N/A	Flare Traversable LT?	N/A	N/A	Flare Traversable RT?	N/A
N/A	Landing Length (in)	N/A	N/A	DWS Provided?	N/A
N/A	Landing Width (in)	N/A	N/A	DWS Contrast?	N/A
N/A	Landing Slope (%)	N/A	N/A	DWS Length (in)	N/A
N/A	Landing X Slope (%)	N/A	N/A	DWS Full Width?	N/A
N/A	Landing Curb? (Y/N)	N/A	N/A	DWS Offset (in)	N/A
N/A	Shared Landing?	N/A			
N/A	Gutter Ponding?	N/A	N/A	Gutter Slope (%)	N/A
N/A	Gutter Lip Ht (in)	N/A	N/A	Gutter X Slope (%)	N/A
N/A	Painted X Walk1?	No	N/A	Painted X Walk2?	No
	X Walk 1 Direction	To E		X Walk 2 Direction	To N
N/A	X Walk 1 Width (in)	N/A	N/A	X Walk 2 Width (in)	N/A
	X Walk 1 Slope (%)	3.2		X Walk 2 Slope (%)	2.6
	X Walk 1 X Slope (%)	2.3		X Walk 2 X Slope (%)	1.6

N/A	Ramp inside XWalk1?	N/A	N/A	Ramp inside XWalk2?	N/A
	Road Slope (%)	1.1	N/A	Clear Space?	N/A
	Road X Slope (%)	2.7	N/A	Clear Space to XWalk (in)	N/A
N/A	Any Obstructions?	N/A	N/A	Storm Grate/Utility Hazard?	N/A
	Obstruction Type			Storm Grate/Utility Type	
		N/A			N/A
			Yes	Surface Condition? (G/P)	Good

**Remove & Replace Curb Ramp With Two New Directional Ramps or Equivalent.**

**R304.5.1**

Total Cost: \$ 3200.00
