Access Compliance Report

Public Rights-of-Way

(Curb Ramps)

| Intersection ID: 43248 | Main Street: LAMPLIGHTER_PL | Cross Street: STONEMAN_PL | Location: SW |

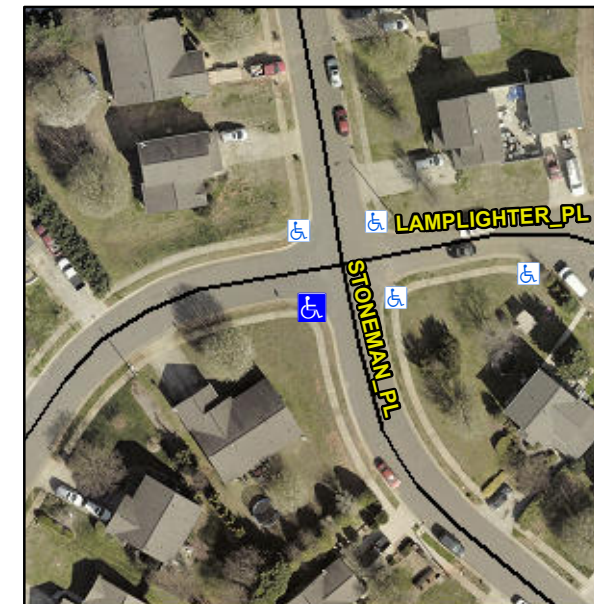
R304.5.1, R304.5.3

| Compliance | Description | Data | Compliance | Description | Data |
|---|---|---|---|---|---|
| No | Ramp Width (in) | 30.0 | No | BlendTrans XSlope (%) | 8.8 |

Remove & Replace Curb Ramp With Two New Directional Ramps or Equivalent.

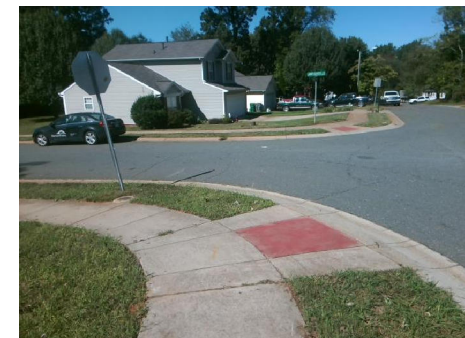
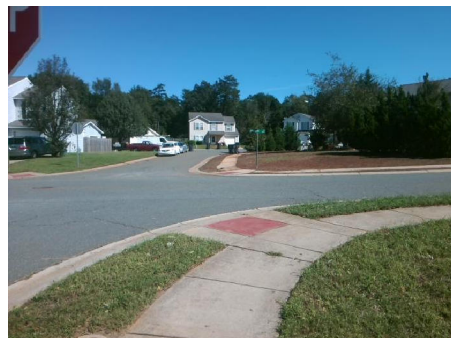
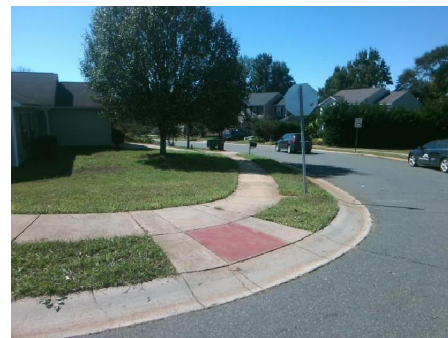
Street 1 Name **STONEMAN PL**
 Stop Condition-Street 1 **None**
 Street 2 Name **LAMPLIGHTER PL**
 Stop Condition-Street 2 **StopSign**
