Intersection ID: 19457	Main Street: S_TRYON_ST	Cross Street: YORKDALE_DR	Location:	NE
ADA ID: C9EAB091A719	Ramp Type: PerpDiag	Initial Pass/Fail: Fail	Overall Compliance: No	Severity Score: 33.75

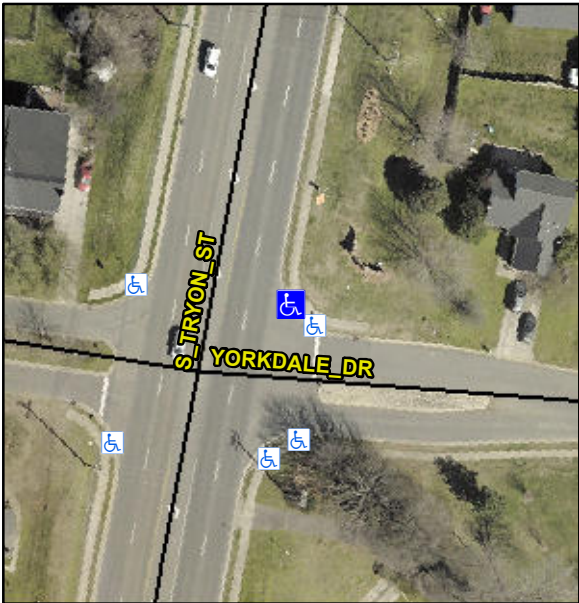
Possible Solutions:	Compliance		Description		Data	Compliance	Description		Data
	Remove & Replace Curb Ramp With Two New Directional Ramps or Equivalent.	N/A	Ramp Length (in)	91.0	No	Ramp Slope (%)	9.0			
		No	Ramp Width (in)	39.0	No	Ramp XSlope (%)	6.1			
		N/A	Flare Type LT	N/A	N/A	Flare Type RT	N/A			
		N/A	Flare Slope LT (%)	N/A	N/A	Flare Slope RT (%)	N/A			
		N/A	Flare Traversable LT?	N/A	N/A	Flare Traversable RT?	N/A			
	Surveyor Notes:	N/A	Landing Length (in)	N/A	N/A	DWS Provided?	N/A			
		N/A	Landing Width (in)	N/A	N/A	DWS Contrast?	N/A			
		N/A	Landing Slope (%)	N/A	N/A	DWS Length (in)	N/A			
		N/A	Landing X Slope (%)	N/A	N/A	DWS Full Width?	N/A			
N/A		Landing Curb? (Y/N)	N/A	N/A	DWS Offset (in)	N/A				
PROW/ADA:	N/A	Shared Landing?	N/A							
	N/A	Gutter Ponding?	N/A	N/A	Gutter Slope (%)	N/A				
	N/A	Gutter Lip Ht (in)	N/A	N/A	Gutter X Slope (%)	N/A

N/A	Painted X Walk1?	No	N/A	Painted X Walk2?	No				
		X Walk 1 Direction	To W		X Walk 2 Direction	To S				
	N/A	X Walk 1 Width (in)	N/A	N/A	X Walk 2 Width (in)	N/A				
		X Walk 1 Slope (%)	8.0		X Walk 2 Slope (%)	1.4				
		X Walk 1 X Slope (%)	1.0		X Walk 2 X Slope (%)	8.3				
	N/A	Ramp inside XWalk1?	N/A	N/A	Ramp inside XWalk2?	N/A				
		Road Slope (%)	5.4	N/A	Clear Space?	N/A				
		Road X Slope (%)	7.3	N/A	Clear Space to XWalk (in)	N/A				
	N/A	Any Obstructions?	N/A	N/A	Storm Grate/Utility Hazard?	N/A				
		Obstruction Type			Storm Grate/Utility Type					
			N/A			N/A				
Total Cost:		\$	3200.00	Yes	Surface Condition? (G/P)	Good				
Street 1 Name		S TRYON ST								
Stop Condition-Street 2		None								
Street 2 Name		YORKDALE DR								
Stop Condition-Street 1		StopSign
