# Access Compliance Report

## Public Rights-of-Way

### (Curb Ramps)

Intersection ID: 10010	Main Street: DUNCROFT_LN	Cross Street: E_W_T_HARRIS_BV	Location: SW
ADA ID: C9EFBCC55116	Ramp Type: PerpDiag	Initial Pass/Fail: Fail	Overall Compliance: No
Severity Score: 10			
Codes/Mitigation Info/Possible Solution		Field Measurements/Component Compliance

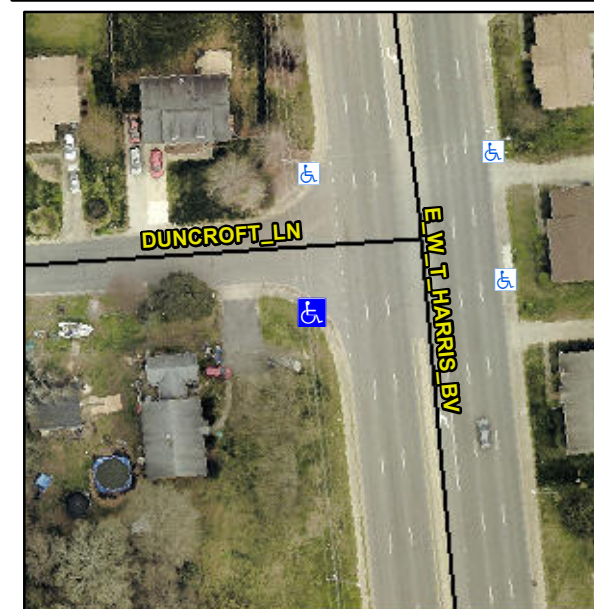
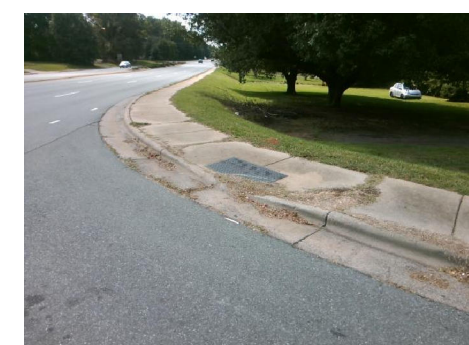
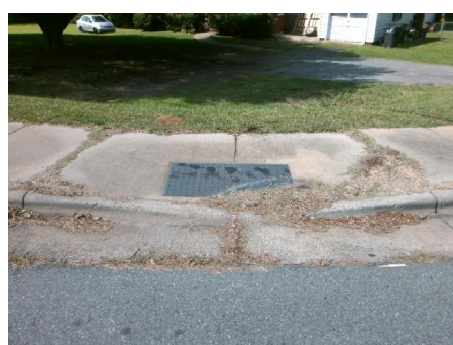
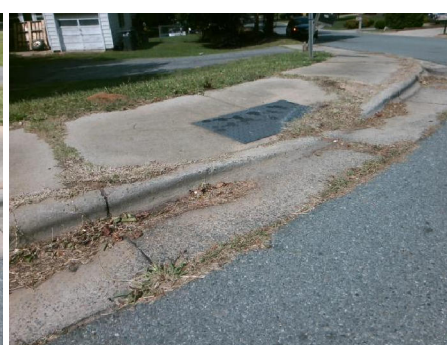
**Not Found, R304.5.1, R304.5.3**

Compliance	Description	Data	Compliance	Description	Data
N/A	Ramp Length (in)	60.0	Yes	Ramp Slope (%)	7.1
No	Ramp Width (in)	37.0	No	Ramp XSlope (%)	3.9
N/A	Flare Type LT	N/A	N/A	Flare Type RT	N/A
N/A	Flare Slope LT (%)	N/A	N/A	Flare Slope RT (%)	N/A
N/A	Flare Traversable LT?	N/A	N/A	Flare Traversable RT?	N/A
N/A	Landing Length (in)	N/A	N/A	DWS Provided?	N/A
N/A	Landing Width (in)	N/A	N/A	DWS Contrast?	N/A
N/A	Landing Slope (%)	N/A	N/A	DWS Length (in)	N/A
N/A	Landing X Slope (%)	N/A	N/A	DWS Full Width?	N/A
N/A	Landing Curb? (Y/N)	N/A	N/A	DWS Offset (in)	N/A
N/A	Shared Landing?	N/A			
N/A	Gutter Ponding?	Yes	N/A	Gutter Slope (%)	N/A
N/A	Gutter Lip Ht (in)	N/A	N/A	Gutter X Slope (%)	N/A
N/A	Painted X Walk1?	No	N/A	Painted X Walk2?	No
	X Walk 1 Direction	To E		X Walk 2 Direction	To N
N/A	X Walk 1 Width (in)	N/A	N/A	X Walk 2 Width (in)	N/A
	X Walk 1 Slope (%)	1.7		X Walk 2 Slope (%)	0.9
	X Walk 1 X Slope (%)	0.3		X Walk 2 X Slope (%)	5.6

N/A	Ramp inside XWalk1?	N/A	N/A	Ramp inside XWalk2?	N/A
	Road Slope (%)	2.7	N/A	Clear Space?	N/A
	Road X Slope (%)	4.1	N/A	Clear Space to XWalk (in)	N/A
N/A	Any Obstructions?	N/A	N/A	Storm Grate/Utility Hazard?	N/A
	Obstruction Type			Storm Grate/Utility Type	
		N/A			N/A
		Yes		Surface Condition? (G/P)	Good

**Remove & Replace Curb Ramp With Two New Directional Ramps or Equivalent.**
