Access Compliance Report Public Rights-of-Way (Curb Ramps)

Intersection ID: 10027410Main Street: GOLF_ACRES_DRCross Street: N/ALocation: NWADA ID: C9FACB0677E7Ramp Type: PerpInitial Pass/Fail: FailOverall Compliance: NoSeverity Score: 22.5

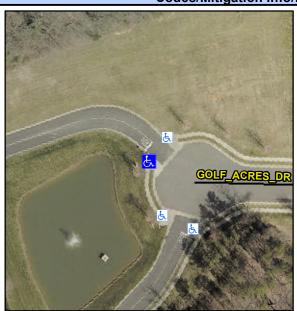
PROW/ADA:
Not Found, R304.5.1, R304.2.2, R304.5.3

| Compliance Description Data | | Data | Compliance Description | | Data |
|---|---|---|---|---|---|
| N/A | Ramp Length (in) | 48.0 | No | Ramp Slope (%) | 9.5 |
| No | Ramp Width (in) | 36.0 | No | Ramp XSlope (%) | 3.5 |

Possible Solutions:
Remove & Replace Entire Ramp.

Total Cost: \$ 1850.00
