Access Compliance Report

Public Rights-of-Way

(Curb Ramps)

Intersection ID: 3107	Main Street: GROSBEAK_LN	Cross Street: MOURNING_DOVE_LN	Location:	S
ADA ID: CA053BBEE8EE	Ramp Type: Perp	Initial Pass/Fail: Fail	Overall Compliance: No	Severity Score: 8.75
Codes/Mitigation Info/Possible Solution		Field Measurements/Component Compliance

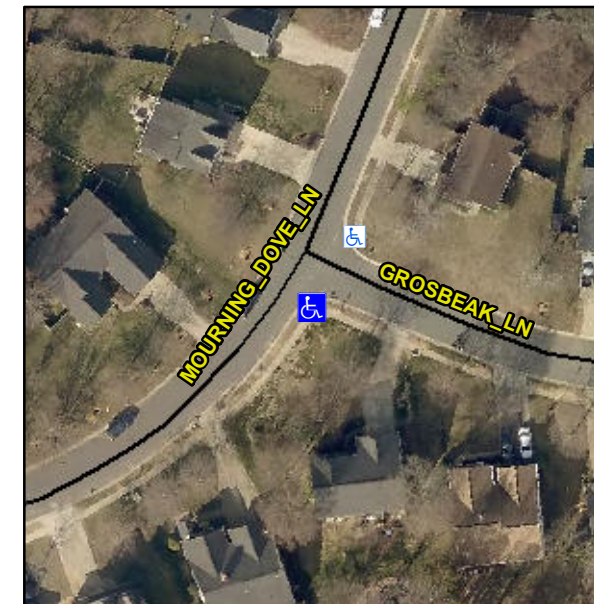
Compliance	Description	Data	Compliance	Description	Data
N/A	Ramp Length (in)	50.5	Yes	Ramp Slope (%)	7.4
No	Ramp Width (in)	45.0	Yes	Ramp XSlope (%)	0.5
N/A	Flare Type LT	N/A	N/A	Flare Type RT	N/A
N/A	Flare Slope LT (%)	N/A	N/A	Flare Slope RT (%)	N/A
N/A	Flare Traversable LT?	N/A	N/A	Flare Traversable RT?	N/A
N/A	Landing Length (in)	N/A	N/A	DWS Provided?	N/A
N/A	Landing Width (in)	N/A	N/A	DWS Contrast?	N/A
N/A	Landing Slope (%)	N/A	N/A	DWS Length (in)	N/A
N/A	Landing X Slope (%)	N/A	N/A	DWS Full Width?	N/A
N/A	Landing Curb? (Y/N)	N/A	N/A	DWS Offset (in)	N/A
N/A	Shared Landing?	N/A			
N/A	Gutter Ponding?	N/A	N/A	Gutter Slope (%)	N/A
N/A	Gutter Lip Ht (in)	N/A	N/A	Gutter X Slope (%)	N/A
N/A	Painted X Walk1?	No	N/A	Painted X Walk2?	N/A
	X Walk 1 Direction	To NE		X Walk 2 Direction	N/A
N/A	X Walk 1 Width (in)	N/A	N/A	X Walk 2 Width (in)	N/A
	X Walk 1 Slope (%)	1.7		X Walk 2 Slope (%)	N/A
	X Walk 1 X Slope (%)	2.6		X Walk 2 X Slope (%)	N/A

N/A	Ramp inside XWalk1?	N/A	N/A	Ramp inside XWalk2?	N/A
	Road Slope (%)	N/A	N/A	Clear Space?	N/A
	Road X Slope (%)	N/A	N/A	Clear Space to XWalk (in)	N/A
N/A	Any Obstructions?	N/A	N/A	Storm Grate/Utility Hazard?	N/A
	Obstruction Type			Storm Grate/Utility Type	
		N/A			N/A
			Yes	Surface Condition? (G/P)	Good

Possible Solutions:

Remove & Replace Entire Ramp.

R304.5.1
