# Access Compliance Report

## Public Rights-of-Way

### (Curb Ramps)

| Intersection ID: 10035429 | Main Street: RANDOLPH_RD | Cross Street: N/A | Location: | S |

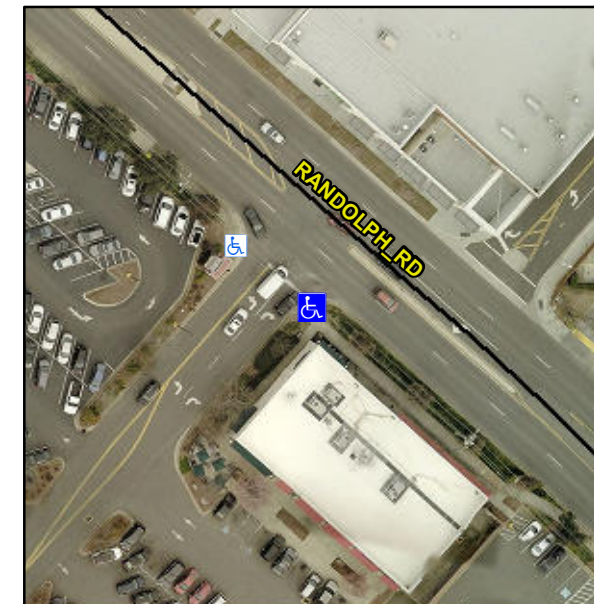
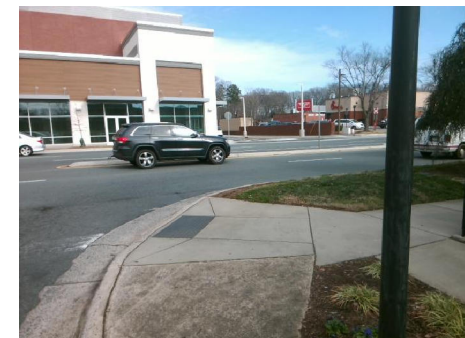
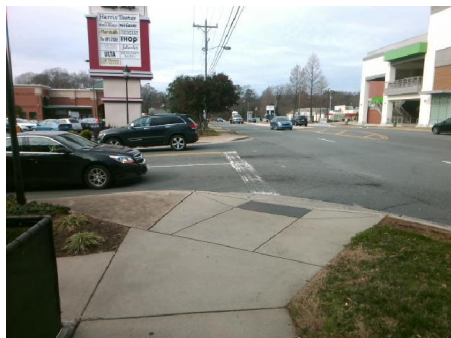
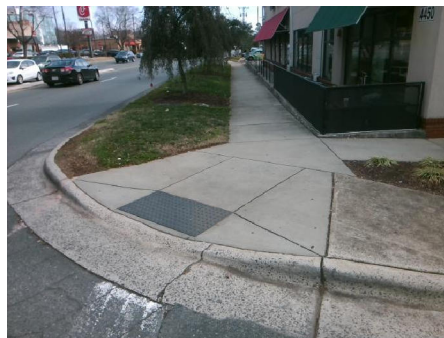
| ADA ID: CA10E7475DD7 | Ramp Type: BlendTrans1 | Initial Pass/Fail: Pass | Overall Compliance: No | Severity Score: 0 |

**LNDG SLOPE NEGATIVE**

**Not Found, R304.2.2-Perp, R304.3.2-Para, R305.2**

| Compliance | Description | Data | Compliance | Description | Data |
|---|---|---|---|---|---|
| No | Landing Slope (%) | 3.9 | Yes | DWS Length (in) | 24.0 |
| N/A | Landing Curb? (Y/N) | No | No | DWS Offset (in) | 3.0 |
| | | | No | Curb Slope (%) | 22.0 |

**Remove & Replace Curb Ramp With Two New Directional Ramps or Equivalent.**

Total Cost: \$ 3200.00
