Access Compliance Report

Public Rights-of-Way

(Curb Ramps)

Intersection ID: 23833	Main Street: FOXRIDGE_RD	Cross Street: MCALPINE_FARM_RD	Location: NW
ADA ID: CA1110DA1EB1	Ramp Type: Perp	Initial Pass/Fail: Fail	Overall Compliance: No
Severity Score: 12.5			
Codes/Mitigation Info/Possible Solution		Field Measurements/Component Compliance

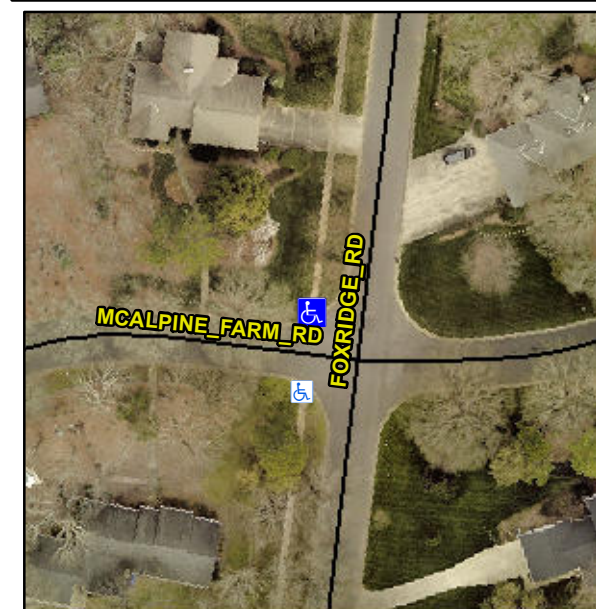
Compliance	Description	Data	Compliance	Description	Data
N/A	Ramp Length (in)	44.0	Yes	Ramp Slope (%)	5.5
Yes	Ramp Width (in)	53.0	No	Ramp XSlope (%)	6.5
N/A	Flare Type LT	N/A	N/A	Flare Type RT	N/A
N/A	Flare Slope LT (%)	N/A	N/A	Flare Slope RT (%)	N/A
N/A	Flare Traversable LT?	N/A	N/A	Flare Traversable RT?	N/A
N/A	Landing Length (in)	N/A	N/A	DWS Provided?	N/A
N/A	Landing Width (in)	N/A	N/A	DWS Contrast?	N/A
N/A	Landing Slope (%)	N/A	N/A	DWS Length (in)	N/A
N/A	Landing X Slope (%)	N/A	N/A	DWS Full Width?	N/A
N/A	Landing Curb? (Y/N)	N/A	N/A	DWS Offset (in)	N/A
N/A	Shared Landing?	N/A			
N/A	Gutter Ponding?	N/A	N/A	Gutter Slope (%)	N/A
N/A	Gutter Lip Ht (in)	N/A	N/A	Gutter X Slope (%)	N/A
N/A	Painted X Walk1?	No	N/A	Painted X Walk2?	N/A
	X Walk 1 Direction	To SW		X Walk 2 Direction	N/A
N/A	X Walk 1 Width (in)	N/A	N/A	X Walk 2 Width (in)	N/A
	X Walk 1 Slope (%)	1.5		X Walk 2 Slope (%)	N/A
	X Walk 1 X Slope (%)	0.8		X Walk 2 X Slope (%)	N/A

N/A	Ramp inside XWalk1?	N/A	N/A	Ramp inside XWalk2?	N/A
	Road Slope (%)	N/A	N/A	Clear Space?	N/A
	Road X Slope (%)	N/A	N/A	Clear Space to XWalk (in)	N/A
N/A	Any Obstructions?	N/A	N/A	Storm Grate/Utility Hazard?	N/A
	Obstruction Type			Storm Grate/Utility Type	
		N/A			N/A
			Yes	Surface Condition? (G/P)	Good

Possible Solutions:

Remove & Replace Entire Ramp.

R304.5.3

\$ 1850.00
