Access Compliance Report

Public Rights-of-Way

(Curb Ramps)

Intersection ID: 19991	Main Street: NATIONS_FORD_RD	Cross Street: REGENCY_EXECUTIVE_PARK_DR	Location: NE
ADA ID: CA13548367E9	Ramp Type: PerpDiag	Initial Pass/Fail: Fail	Overall Compliance: No
Severity Score: 22.5			
Codes/Mitigation Info/Possible Solution		Field Measurements/Component Compliance

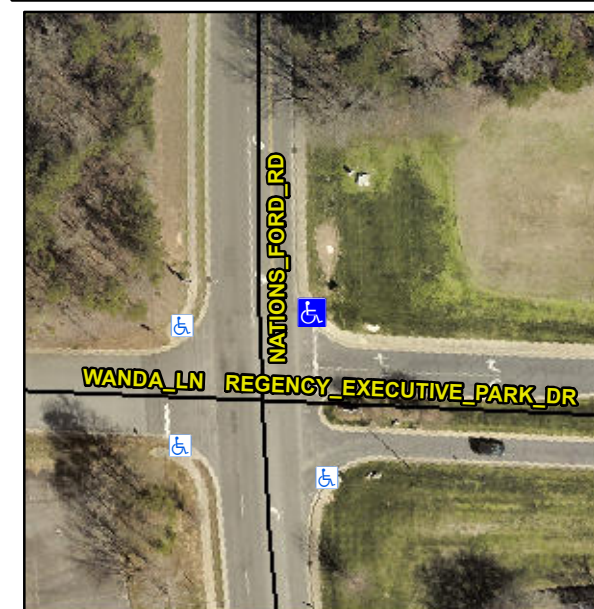
Compliance	Description	Data	Compliance	Description	Data
N/A	Ramp Length (in)	57.5	No	Ramp Slope (%)	9.1
No	Ramp Width (in)	47.0	No	Ramp XSlope (%)	3.9
N/A	Flare Type LT	N/A	N/A	Flare Type RT	N/A
N/A	Flare Slope LT (%)	N/A	N/A	Flare Slope RT (%)	N/A
N/A	Flare Traversable LT?	N/A	N/A	Flare Traversable RT?	N/A
N/A	Landing Length (in)	N/A	N/A	DWS Provided?	N/A
N/A	Landing Width (in)	N/A	N/A	DWS Contrast?	N/A
N/A	Landing Slope (%)	N/A	N/A	DWS Length (in)	N/A
N/A	Landing X Slope (%)	N/A	N/A	DWS Full Width?	N/A
N/A	Landing Curb? (Y/N)	N/A	N/A	DWS Offset (in)	N/A
N/A	Shared Landing?	N/A			
N/A	Gutter Ponding?	N/A	N/A	Gutter Slope (%)	N/A
N/A	Gutter Lip Ht (in)	N/A	N/A	Gutter X Slope (%)	N/A
N/A	Painted X Walk1?	No	N/A	Painted X Walk2?	No
	X Walk 1 Direction	To W		X Walk 2 Direction	To S
N/A	X Walk 1 Width (in)	N/A	N/A	X Walk 2 Width (in)	N/A
	X Walk 1 Slope (%)	4.8		X Walk 2 Slope (%)	0.5
	X Walk 1 X Slope (%)	2.8		X Walk 2 X Slope (%)	7.1

N/A	Ramp inside XWalk1?	N/A	N/A	Ramp inside XWalk2?	N/A
	Road Slope (%)	3.5	N/A	Clear Space?	N/A
	Road X Slope (%)	2.4	N/A	Clear Space to XWalk (in)	N/A
N/A	Any Obstructions?	N/A	N/A	Storm Grate/Utility Hazard?	N/A
	Obstruction Type			Storm Grate/Utility Type	
		N/A			N/A
		Yes		Surface Condition? (G/P)	Good

Possible Solutions:

Remove & Replace Curb Ramp With Two New Directional Ramps or Equivalent.

R304.5.1, R304.2.2, R304.5.3
