Access Compliance Report

Public Rights-of-Way

(Curb Ramps)

Intersection ID: 50344	Main Street: KELBURN_LN	Cross Street: FENWAY_DR	Location: NE
ADA ID: CA13776F92B6	Ramp Type: BlendTrans1	Initial Pass/Fail: Fail	Overall Compliance: No
		Severity Score: 10

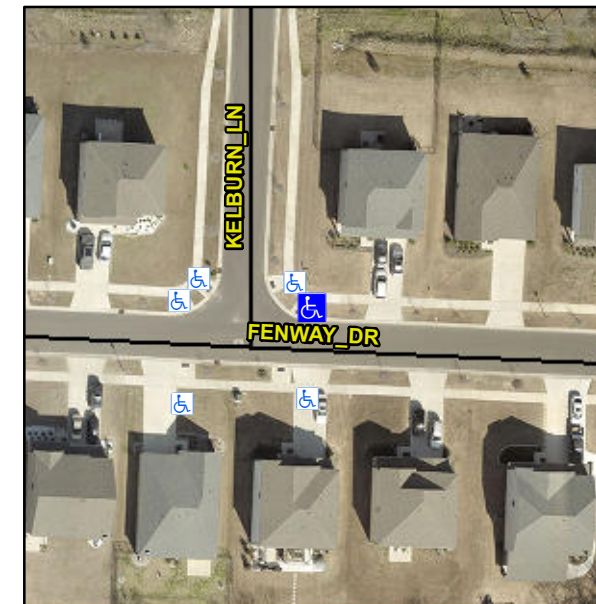
Not Found, R304.5.1, R304.5.3

Compliance	Description	Data	Compliance	Description	Data
N/A	Ramp Length (in)	99.0	Yes	BlendTrans Slope (%)	2.0
No	Ramp Width (in)	47.0	No	BlendTrans XSlope (%)	2.2
N/A	Flare Type LT	N/A	N/A	Flare Type RT	N/A
N/A	Flare Slope LT (%)	N/A	N/A	Flare Slope RT (%)	N/A
N/A	Flare Traversable LT?	N/A	N/A	Flare Traversable RT?	N/A
N/A	Landing Length (in)	N/A	N/A	DWS Provided?	N/A
N/A	Landing Width (in)	N/A	N/A	DWS Contrast?	N/A
N/A	Landing Slope (%)	N/A	N/A	DWS Length (in)	N/A
N/A	Landing X Slope (%)	N/A	N/A	DWS Full Width?	N/A
N/A	Landing Curb? (Y/N)	N/A	N/A	DWS Offset (in)	N/A
N/A	Shared Landing?	N/A			
N/A	Gutter Ponding?	N/A	N/A	Gutter Slope (%)	N/A
N/A	Gutter Lip Ht (in)	1.0	N/A	Gutter X Slope (%)	N/A
N/A	Painted X Walk1?	No	N/A	Painted X Walk2?	N/A
	X Walk 1 Direction	To S		X Walk 2 Direction	N/A
	X Walk 1 Width (in)	N/A		X Walk 2 Width (in)	N/A
	X Walk 1 Slope (%)	2.3		X Walk 2 Slope (%)	N/A
	X Walk 1 X Slope (%)	2.0		X Walk 2 X Slope (%)	N/A

N/A	Ramp inside XWalk1?	N/A	N/A	Ramp inside XWalk2?	N/A
	Road Slope (%)	2.0		Clear Space?	N/A
	Road X Slope (%)	2.3	N/A	Clear Space to XWalk (in)	N/A
N/A	Any Obstructions?	N/A	N/A	Storm Grate/Utility Hazard?	N/A
	Obstruction Type			Storm Grate/Utility Type	
		N/A			N/A
			Yes	Surface Condition? (G/P)	Good
			No	Curb Slope (%)	6.6

Remove & Replace Curb Ramp With Two New Directional Ramps or Equivalent.
