# Access Compliance Report

## Public Rights-of-Way

Intersection ID: 29698	Main Street: SIMFIELD_CHURCH_RD	Cross Street: WOODCROFT_WY	Location: SW
ADA ID: CA250108F91F	Ramp Type: Perp	Initial Pass/Fail: Fail	Overall Compliance: No
Severity Score: 21.25			
Codes/Mitigation Info/Possible Solution		Field Measurements/Component Compliance

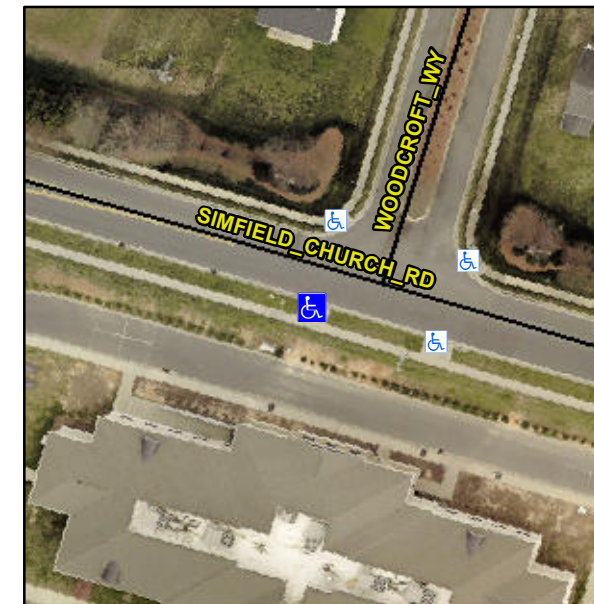
**Not Found, R304.5.1, R304.2.2**

Compliance	Description	Data	Compliance	Description	Data
N/A	Ramp Length (in)	96.0	No	Ramp Slope (%)	8.6
No	Ramp Width (in)	47.0	Yes	Ramp XSlope (%)	0.6
N/A	Flare Type LT	N/A	N/A	Flare Type RT	N/A
N/A	Flare Slope LT (%)	N/A	N/A	Flare Slope RT (%)	N/A
N/A	Flare Traversable LT?	N/A	N/A	Flare Traversable RT?	N/A
N/A	Landing Length (in)	N/A	N/A	DWS Provided?	N/A
N/A	Landing Width (in)	N/A	N/A	DWS Contrast?	N/A
N/A	Landing Slope (%)	N/A	N/A	DWS Length (in)	N/A
N/A	Landing X Slope (%)	N/A	N/A	DWS Full Width?	N/A
N/A	Landing Curb? (Y/N)	N/A	N/A	DWS Offset (in)	N/A
N/A	Shared Landing?	N/A			
N/A	Gutter Ponding?	N/A	N/A	Gutter Slope (%)	N/A
N/A	Gutter Lip Ht (in)	N/A	N/A	Gutter X Slope (%)	N/A
N/A	Painted X Walk1?	No	N/A	Painted X Walk2?	N/A
	X Walk 1 Direction	To N		X Walk 2 Direction	N/A
N/A	X Walk 1 Width (in)	N/A	N/A	X Walk 2 Width (in)	N/A
	X Walk 1 Slope (%)	1.7		X Walk 2 Slope (%)	N/A
	X Walk 1 X Slope (%)	1.0		X Walk 2 X Slope (%)	N/A

**Remove & Replace Entire Ramp.**

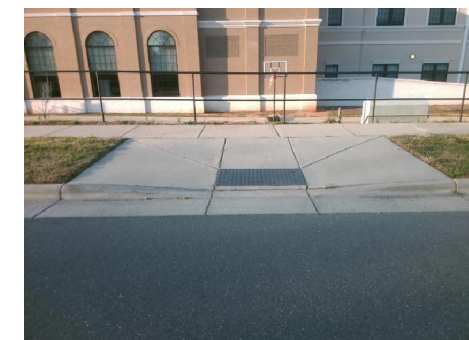
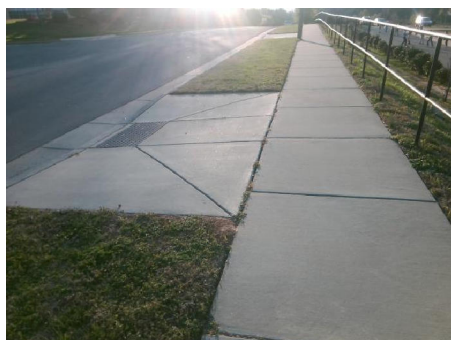
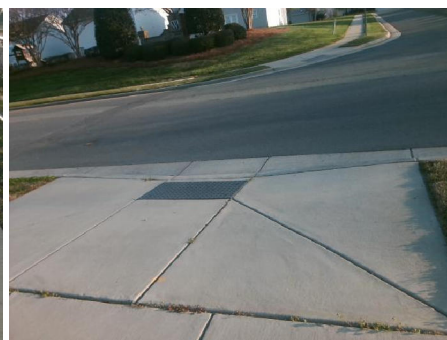
N/A	Ramp inside XWalk1?	N/A	N/A	Ramp inside XWalk2?	N/A
	Road Slope (%)	N/A	N/A	Clear Space?	N/A
	Road X Slope (%)	N/A	N/A	Clear Space to XWalk (in)	N/A
N/A	Any Obstructions?	N/A	N/A	Storm Grate/Utility Hazard?	N/A
	Obstruction Type			Storm Grate/Utility Type	
		N/A			N/A
			Yes	Surface Condition? (G/P)	Good
