Intersection ID: 10000	Main Street: FONTANA_AV	Cross Street: WHISNANT_ST	Location:	SW
ADA ID: CA26885EE68B	Ramp Type: Perp	Initial Pass/Fail: Fail	Overall Compliance: No	Severity Score: 33.75

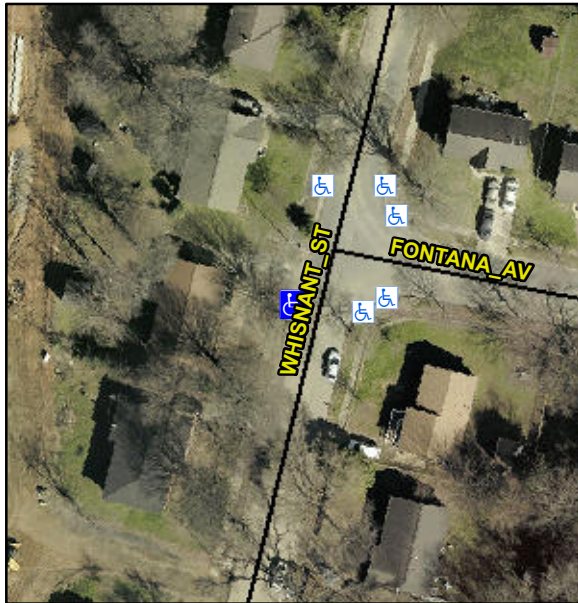
Not Found, R304.5.1, R304.2.2

Possible Solutions:			Compliance	Description	Data	Compliance	Description	Data
Remove & Replace Entire Ramp.	N/A	Ramp Length (in)	53.5	No	Ramp Slope (%)	14.9		
	No	Ramp Width (in)	39.0	Yes	Ramp XSlope (%)	1.0		
	N/A	Flare Type LT	N/A	N/A	Flare Type RT	N/A		
	N/A	Flare Slope LT (%)	N/A	N/A	Flare Slope RT (%)	N/A		
	N/A	Flare Traversable LT?	N/A	N/A	Flare Traversable RT?	N/A		
	N/A	Landing Length (in)	N/A	N/A	DWS Provided?	N/A		
	N/A	Landing Width (in)	N/A	N/A	DWS Contrast?	N/A		
	N/A	Landing Slope (%)	N/A	N/A	DWS Length (in)	N/A		
	N/A	Landing X Slope (%)	N/A	N/A	DWS Full Width?	N/A		
	N/A	Landing Curb? (Y/N)	N/A	N/A	DWS Offset (in)	N/A		
Surveyor Notes:	N/A	Shared Landing?	N/A					
PROW/ADA:	N/A	Gutter Ponding?	N/A	N/A	Gutter Slope (%)	N/A		
	N/A	Gutter Lip Ht (in)	N/A	N/A	Gutter X Slope (%)	N/A		
	N/A	Painted X Walk1?	No	N/A	Painted X Walk2?	N/A		
		X Walk 1 Direction	To E		X Walk 2 Direction	N/A		
	N/A	X Walk 1 Width (in)	N/A	N/A	X Walk 2 Width (in)	N/A

X Walk 1 Slope (%)	5.1		X Walk 2 Slope (%)	N/A		
		X Walk 1 X Slope (%)	1.8		X Walk 2 X Slope (%)	N/A		
	N/A	Ramp inside XWalk1?	N/A	N/A	Ramp inside XWalk2?	N/A		
		Road Slope (%)	N/A	N/A	Clear Space?	N/A		
		Road X Slope (%)	N/A	N/A	Clear Space to XWalk (in)	N/A		
	N/A	Any Obstructions?	N/A	N/A	Storm Grate/Utility Hazard?	N/A		
		Obstruction Type			Storm Grate/Utility Type			
			N/A			N/A		
				Yes	Surface Condition? (G/P)	Good		
	Total Cost:	\$	1850.00

Remove & Replace Entire Ramp.
