| Intersection ID: 8303 | Main Street: IRMA_ST | Cross Street: CATHERINE_SIMMONS_AV | Location: | SE |
| ADA ID: CA311D63B1B9 | Ramp Type: Perp | Initial Pass/Fail: Pass | Overall Compliance: No | Severity Score: 15.25 |

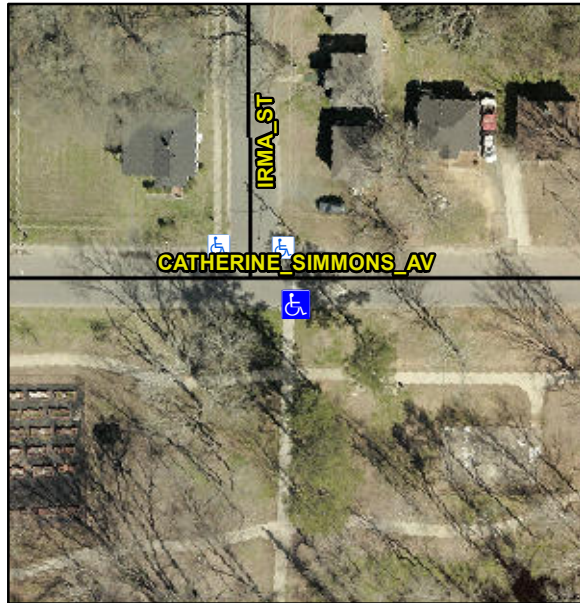
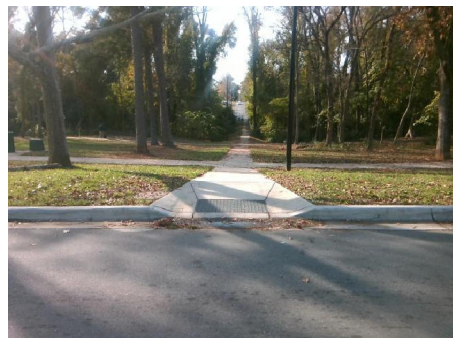
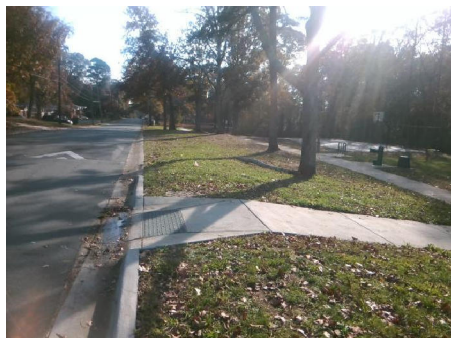
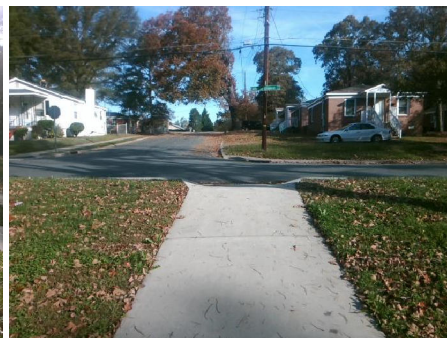
**Not Found, R304.5.3, R304.2.1,  
R304.2.2-Perp, R304.3.2-Para,  
R302.7, R304.5.4**

| Compliance | Description | Data | Compliance | Description | Data |
|---|---|---|---|---|---|
| Yes | Ramp Width (in) | 48.0 | No | Ramp XSlope (%) | 2.3 |
| No | Landing Length (in) | N/A | Yes | DWS Provided? | Yes |
| No | Landing Width (in) | N/A | Yes | DWS Contrast? | Yes |
| No | Landing Slope (%) | N/A | Yes | DWS Length (in) | 24.5 |
| No | Landing X Slope (%) | N/A | Yes | DWS Full Width? | Yes |
| No | Gutter Ponding? | Yes | No | Gutter Slope (%) | 8.6 |

**Remove & Replace Entire Ramp.  
Remove & Replace Gutter.**

**Total Cost: \$ 2600.00**
