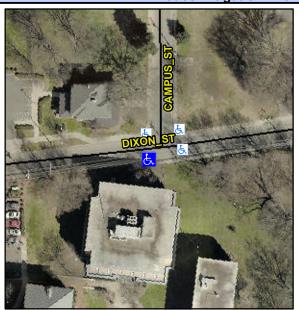
Intersection ID: 10281Main Street: CAMPUS_STCross Street: DIXON_STLocation:SWADA ID: CA381BE9D9C2Ramp Type: PerpInitial Pass/Fail: FailOverall Compliance: NoSeverity Score:10

| u33/1 | an. ran Overan | Compilan | icc. it | o deventy ocore. | | |
|---|---|---|---|---|---|--|
| N/A | Ramp Length (in) | 54.0 | Yes | Ramp Slope (%) | 7.3 | |
| No | Ramp Width (in) | 46.0 | No | Ramp XSlope (%) | 3.0 | |

| Possible Solution | |
|---|---|
| Remove & Replace Entire Ramp. | N/A |
| R304.5.1, R304.5.3 | N/A |

1850.00
