Access Compliance Report

Public Rights-of-Way

(Curb Ramps)

Intersection ID: 10022670	Main Street: CARMENET_LN	Cross Street: N/A	Location: S
ADA ID: CA3923C7F865	Ramp Type: Perp	Initial Pass/Fail: Fail	Overall Compliance: No
Severity Score: 8.75			
Codes/Mitigation Info/Possible Solution		Field Measurements/Component Compliance

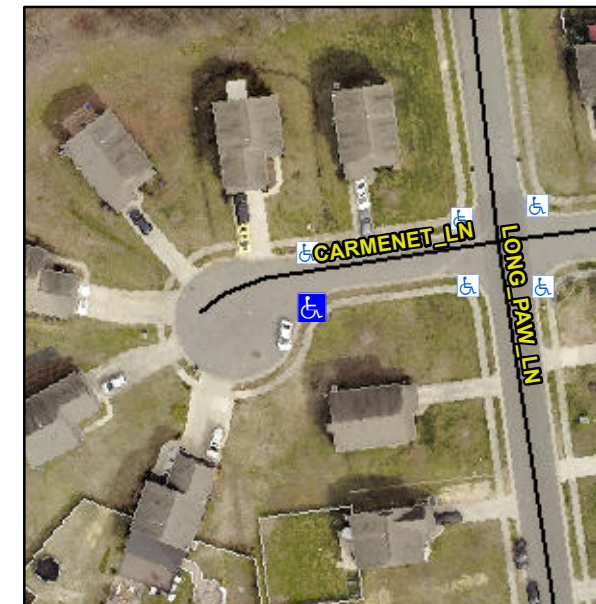
Compliance	Description	Data	Compliance	Description	Data
N/A	Ramp Length (in)	48.5	Yes	Ramp Slope (%)	7.6
No	Ramp Width (in)	41.0	Yes	Ramp XSlope (%)	1.4
N/A	Flare Type LT	N/A	N/A	Flare Type RT	N/A
N/A	Flare Slope LT (%)	N/A	N/A	Flare Slope RT (%)	N/A
N/A	Flare Traversable LT?	N/A	N/A	Flare Traversable RT?	N/A
N/A	Landing Length (in)	N/A	N/A	DWS Provided?	N/A
N/A	Landing Width (in)	N/A	N/A	DWS Contrast?	N/A
N/A	Landing Slope (%)	N/A	N/A	DWS Length (in)	N/A
N/A	Landing X Slope (%)	N/A	N/A	DWS Full Width?	N/A
N/A	Landing Curb? (Y/N)	N/A	N/A	DWS Offset (in)	N/A
N/A	Shared Landing?	N/A			
N/A	Gutter Ponding?	N/A	N/A	Gutter Slope (%)	N/A
N/A	Gutter Lip Ht (in)	N/A	N/A	Gutter X Slope (%)	N/A
N/A	Painted X Walk1?	No	N/A	Painted X Walk2?	N/A
	X Walk 1 Direction	To N		X Walk 2 Direction	N/A
N/A	X Walk 1 Width (in)	N/A	N/A	X Walk 2 Width (in)	N/A
	X Walk 1 Slope (%)	3.0		X Walk 2 Slope (%)	N/A
	X Walk 1 X Slope (%)	1.9		X Walk 2 X Slope (%)	N/A

N/A	Ramp inside XWalk1?	N/A	N/A	Ramp inside XWalk2?	N/A
	Road Slope (%)	N/A	N/A	Clear Space?	N/A
	Road X Slope (%)	N/A	N/A	Clear Space to XWalk (in)	N/A
N/A	Any Obstructions?	N/A	N/A	Storm Grate/Utility Hazard?	N/A
	Obstruction Type			Storm Grate/Utility Type	
		N/A			N/A
			Yes	Surface Condition? (G/P)	Good

Possible Solutions:

Remove & Replace Entire Ramp.
