Access Compliance Report

Public Rights-of-Way

(Curb Ramps)

Intersection ID: 46821	Main Street: RED_PINE_CT	Cross Street: AZALEA_HILLS_DR	Location: W
ADA ID: CA439A71F574	Ramp Type: Perp	Initial Pass/Fail: Fail	Overall Compliance: No
Severity Score: 10			
Codes/Mitigation Info/Possible Solution		Field Measurements/Component Compliance

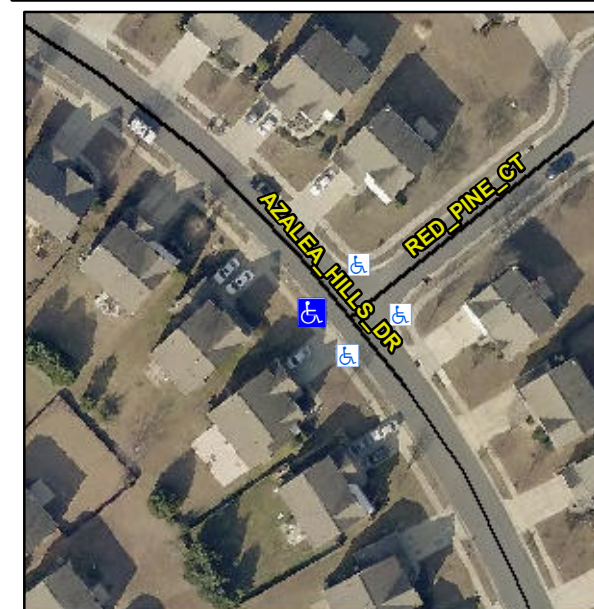
Not Found, R304.5.1, R304.5.3

Compliance	Description	Data	Compliance	Description	Data
N/A	Ramp Length (in)	48.5	Yes	Ramp Slope (%)	8.0
No	Ramp Width (in)	47.0	No	Ramp XSlope (%)	3.1
N/A	Flare Type LT	N/A	N/A	Flare Type RT	N/A
N/A	Flare Slope LT (%)	N/A	N/A	Flare Slope RT (%)	N/A
N/A	Flare Traversable LT?	N/A	N/A	Flare Traversable RT?	N/A
N/A	Landing Length (in)	N/A	N/A	DWS Provided?	N/A
N/A	Landing Width (in)	N/A	N/A	DWS Contrast?	N/A
N/A	Landing Slope (%)	N/A	N/A	DWS Length (in)	N/A
N/A	Landing X Slope (%)	N/A	N/A	DWS Full Width?	N/A
N/A	Landing Curb? (Y/N)	N/A	N/A	DWS Offset (in)	N/A
N/A	Shared Landing?	N/A			
N/A	Gutter Ponding?	N/A	N/A	Gutter Slope (%)	N/A
N/A	Gutter Lip Ht (in)	N/A	N/A	Gutter X Slope (%)	N/A
N/A	Painted X Walk1?	No	N/A	Painted X Walk2?	N/A
	X Walk 1 Direction	To NE		X Walk 2 Direction	N/A
N/A	X Walk 1 Width (in)	N/A	N/A	X Walk 2 Width (in)	N/A
	X Walk 1 Slope (%)	1.8		X Walk 2 Slope (%)	N/A
	X Walk 1 X Slope (%)	1.9		X Walk 2 X Slope (%)	N/A

N/A	Ramp inside XWalk1?	N/A	N/A	Ramp inside XWalk2?	N/A
	Road Slope (%)	N/A	N/A	Clear Space?	N/A
	Road X Slope (%)	N/A	N/A	Clear Space to XWalk (in)	N/A
N/A	Any Obstructions?	N/A	N/A	Storm Grate/Utility Hazard?	N/A
	Obstruction Type			Storm Grate/Utility Type	
		N/A			N/A
			Yes	Surface Condition? (G/P)	Good

Remove & Replace Entire Ramp.

Total Cost: \$ 1850.00
