Access Compliance Report

Public Rights-of-Way

(Curb Ramps)

Intersection ID: 25898	Main Street: BLUE_HERON_DR	Cross Street: CASTLEKEEP_RD	Location:	SE
ADA ID: CA556EC45020	Ramp Type: BlendTrans1	Initial Pass/Fail: Fail	Overall Compliance: No	Severity Score: 12.5
Codes/Mitigation Info/Possible Solution		Field Measurements/Component Compliance

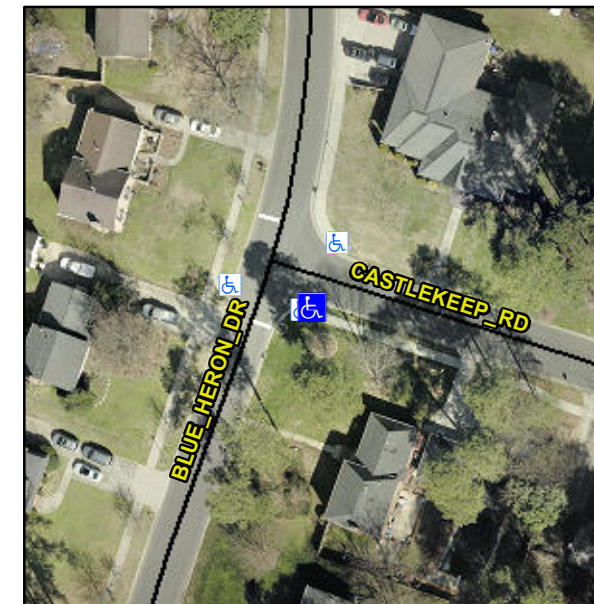
Compliance	Description	Data	Compliance	Description	Data
N/A	Ramp Length (in)	39.0	Yes	BlendTrans Slope (%)	0.4
Yes	Ramp Width (in)	48.0	No	BlendTrans XSlope (%)	5.5
N/A	Flare Type LT	N/A	N/A	Flare Type RT	N/A
N/A	Flare Slope LT (%)	N/A	N/A	Flare Slope RT (%)	N/A
N/A	Flare Traversable LT?	N/A	N/A	Flare Traversable RT?	N/A
N/A	Landing Length (in)	N/A	N/A	DWS Provided?	N/A
N/A	Landing Width (in)	N/A	N/A	DWS Contrast?	N/A
N/A	Landing Slope (%)	N/A	N/A	DWS Length (in)	N/A
N/A	Landing X Slope (%)	N/A	N/A	DWS Full Width?	N/A
N/A	Landing Curb? (Y/N)	N/A	N/A	DWS Offset (in)	N/A
N/A	Shared Landing?	N/A			
N/A	Gutter Ponding?	N/A	N/A	Gutter Slope (%)	N/A
N/A	Gutter Lip Ht (in)	N/A	N/A	Gutter X Slope (%)	N/A
N/A	Painted X Walk1?	No	N/A	Painted X Walk2?	N/A
	X Walk 1 Direction	To N		X Walk 2 Direction	N/A
	X Walk 1 Width (in)	N/A		X Walk 2 Width (in)	N/A
	X Walk 1 Slope (%)	6.8		X Walk 2 Slope (%)	N/A
	X Walk 1 X Slope (%)	0.5		X Walk 2 X Slope (%)	N/A

N/A	Ramp inside XWalk1?	N/A	N/A	Ramp inside XWalk2?	N/A
	Road Slope (%)	0.5		Clear Space?	N/A
	Road X Slope (%)	6.8	N/A	Clear Space to XWalk (in)	N/A
N/A	Any Obstructions?	N/A	N/A	Storm Grate/Utility Hazard?	N/A
	Obstruction Type			Storm Grate/Utility Type	
		N/A			N/A
			Yes	Surface Condition? (G/P)	Good
			No	Curb Slope (%)	12.8

Possible Solutions:

Remove & Replace Curb Ramp With Two New Directional Ramps or Equivalent.
