# Access Compliance Report

## Public Rights-of-Way

### (Curb Ramps)

| Intersection ID: 52306 | Main Street: IMPATIEN_DR | Cross Street: AMERIA_RD | Location: NE |

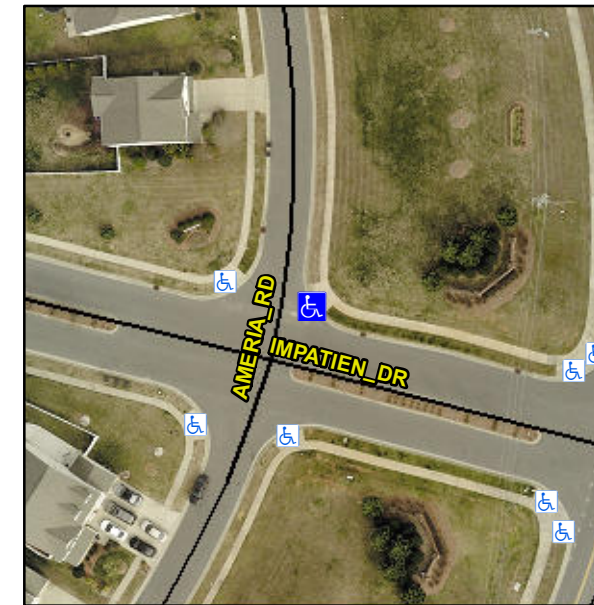
**Not Found, R304.5.1**

| Compliance | Description | Data | Compliance | Description | Data |
|---|---|---|---|---|---|
| No | Ramp Width (in) | 46.0 | Yes | BlendTrans XSlope (%) | 0.4 |
| | | | No | Curb Slope (%) | 22.1 |

**Remove & Replace Curb Ramp With Two New Directional Ramps or Equivalent.**

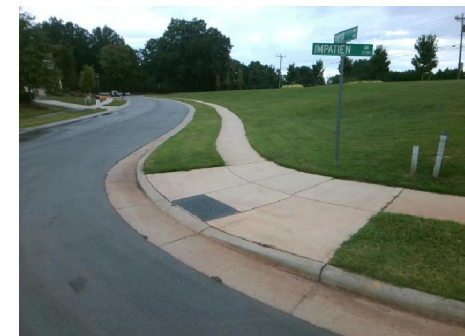
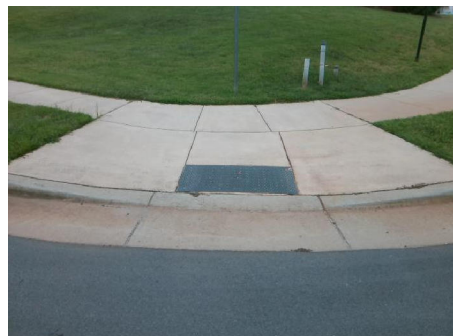
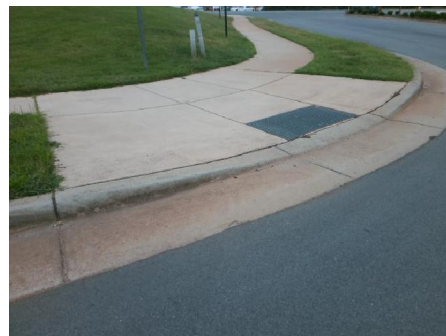
| ADA ID: CA5894EB9E67 | Ramp Type: BlendTrans1 | Initial Pass/Fail: Fail | Overall Compliance: No |
| | | Severity Score: 8.75 | |
