## **Access Compliance Report Public Rights-of-Way** (Curb Ramps)

Intersection ID: 48427 Main Street: DURNESS DR **Cross Street: EVANTON LOCH RD** Location: NE ADA ID: CA6B7AC0A606 Ramp Type: BlendTrans1 Initial Pass/Fail: Fail **Overall Compliance: No Severity Score:** 12.5

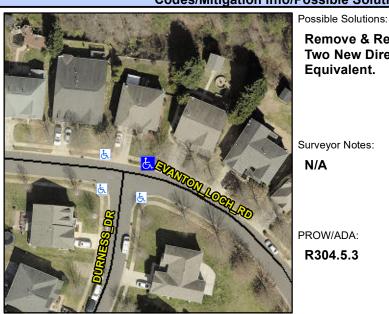
Comp	Compliance Description		Compliance Description		Data
N/A	Ramp Length (in)	47.0	Yes	BlendTrans Slope (%)	4.0
Yes	Ramp Width (in)	48.0	No	BlendTrans XSlope (%)	5.7
N/A	Flare Type LT	N/A	N/A	Flare Type RT	N/A
N/A	Flare Slope LT (%)	N/A	N/A	Flare Slope RT (%)	N/A
N/A	Flare Traversable LT?	N/A	N/A	Flare Traversable RT?	N/A
N/A	Landing Length (in)	N/A	N/A	DWS Provided?	N/A
N/A	Landing Width (in)	N/A	N/A	DWS Contrast?	N/A
N/A	Landing Slope (%)	N/A	N/A	DWS Length (in)	N/A
N/A	Landing X Slope (%)	N/A	N/A	DWS Full Width?	N/A
N/A	Landing Curb? (Y/N)	N/A	N/A	DWS Offset (in)	N/A
N/A	Shared Landing?	N/A			
N/A	Gutter Ponding?	N/A	N/A	Gutter Slope (%)	N/A
N/A	Gutter Lip Ht (in)	N/A	N/A	Gutter X Slope (%)	N/A
N/A	Painted X Walk1?	No	N/A	Painted X Walk2?	N/A
	X Walk 1 Direction	To S		X Walk 2 Direction	N/A
	X Walk 1 Width (in)	N/A		X Walk 2 Width (in)	N/A
	X Walk 1 Slope (%)	4.5		X Walk 2 Slope (%)	N/A
	X Walk 1 X Slope (%)	4.8		X Walk 2 X Slope (%)	N/A

N/A	Ramp inside XWalk1?	N/A	N/A	Ramp inside XWalk2?	N/A
	Road Slope (%)	2.9		Clear Space?	N/A
	Road X Slope (%)	3.9	N/A	Clear Space to XWalk (in)	N/A
N/A	Any Obstructions?	N/A	N/A	Storm Grate/Utility Hazard?	N/A
	Obstruction Type		l	Storm Grate/Utility Type	
		N/A	ļ.		N/A
			Yes	Surface Condition? (G/P)	Good
			N/A	Curb Slope (%)	2.7

**Two New Directional Ramps or** Equivalent.

Remove & Replace Curb Ramp With

R304.5.3
