# Access Compliance Report

## Public Rights-of-Way

### (Curb Ramps)

Intersection ID: 11000	Main Street: NC_MUSIC_FACTORY_BV	Cross Street: JOHNSON_ST	Location: E
ADA ID: CA7A688C8285	Ramp Type: Directional1	Initial Pass/Fail: Fail	Overall Compliance: No
Codes/Mitigation Info/Possible Solution		Field Measurements/Component Compliance	
Severity Score: 13.75

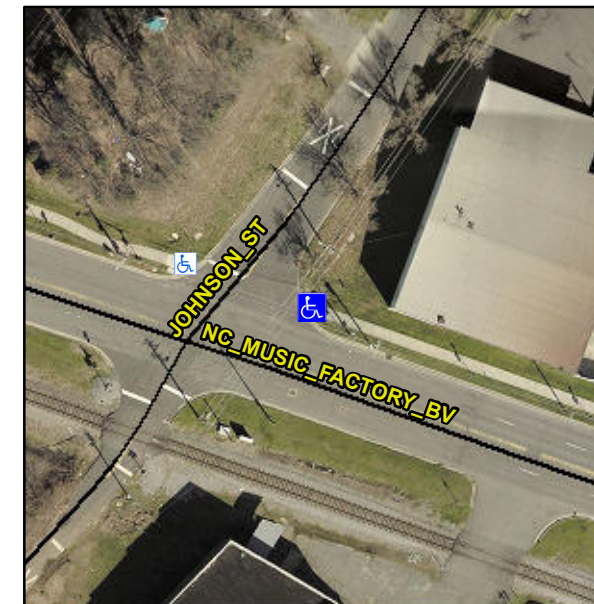
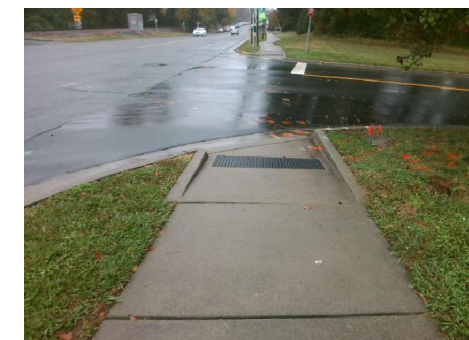
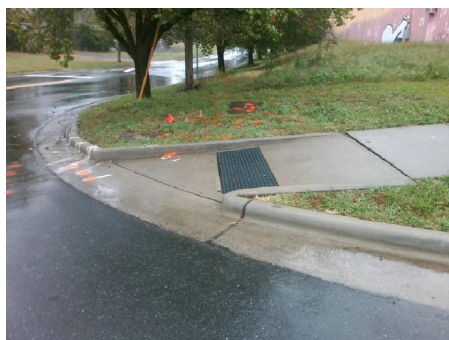
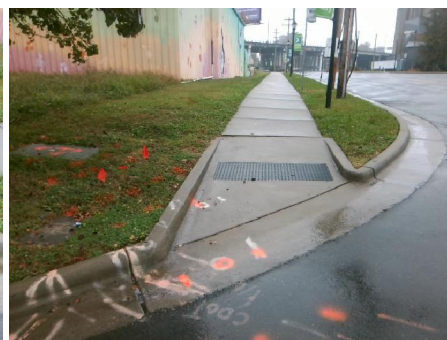
**R304.2.2, R304.5.3**

Compliance	Description	Data	Compliance	Description	Data
N/A	Ramp Length (in)	80.0	N/A	Grade Break?	N/A
Yes	Ramp Width (in)	70.0	N/A	Grade Break Slope (%)	0.0
No	Ramp Slope (%)	11.7	N/A	Grade Break XSlope (%)	0.0
No	Ramp XSlope (%)	2.6			
N/A	Flare Type LT	N/A	N/A	Flare Type RT	N/A
N/A	Flare Slope LT (%)	N/A	N/A	Flare Slope RT (%)	0.0
N/A	Flare Traversable LT?	N/A	N/A	Flare Traversable RT?	N/A
N/A	Landing Length (in)	0.0	N/A	DWS Provided?	N/A
N/A	Landing Width (in)	0.0	N/A	DWS Contrast?	N/A
N/A	Landing Slope (%)	0.0	N/A	DWS Length (in)	N/A
N/A	Landing X Slope (%)	0.0	N/A	DWS Full Width?	N/A
N/A	Landing Curb? (Y/N)	N/A	N/A	DWS Offset LT (in)	N/A
N/A	Shared Landing?	N/A	N/A	DWS Offset RT (in)	N/A
N/A	Gutter Ponding?	0.0	N/A	Gutter Slope (%)	N/A
N/A	Gutter Lip Ht (in)	0.0	N/A	Gutter X Slope (%)	N/A
N/A	Painted X Walk1?	No		Road Slope (%)	0.6
	X Walk 1 Direction	To W		Road X Slope (%)	8.5
	X Walk 1 Width (in)	N/A		Clear Space?	N/A

X Walk 1 Slope (%)	0.6	N/A	Clear Space to XWalk (in)	N/A
	X Walk 1 X Slope (%)	8.5	N/A	Storm Grate/Utility Hazard?	N/A
N/A	Ramp inside XWalk1?	N/A		Storm Grate/Utility Type	
N/A	Any Obstructions?	N/A			N/A
	Obstruction Type		Yes	Surface Condition? (G/P)	Good
			N/A	Curb Slope (%)	9.0

**Remove & Replace Entire Ramp.**
