Access Compliance Report

Public Rights-of-Way

(Curb Ramps)

| Intersection ID: 44076 | Main Street: FOREST_RUN_LN | Cross Street: WESTMILL_LN | Location: SW |

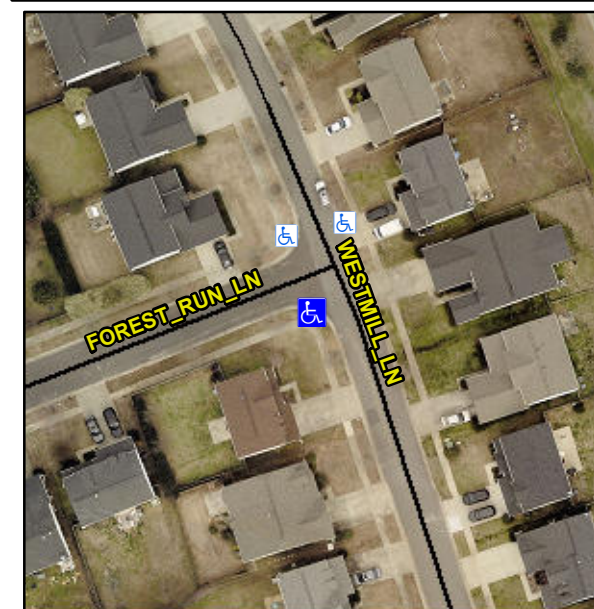
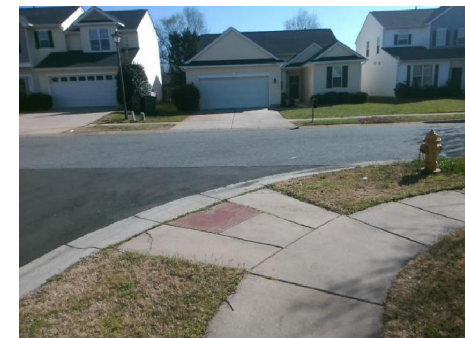
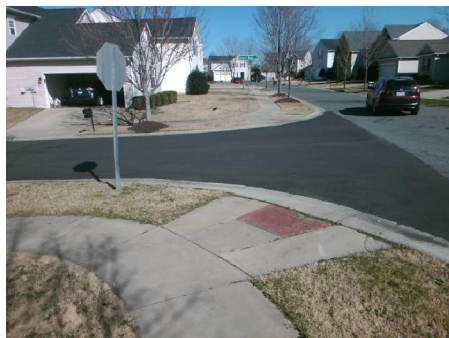
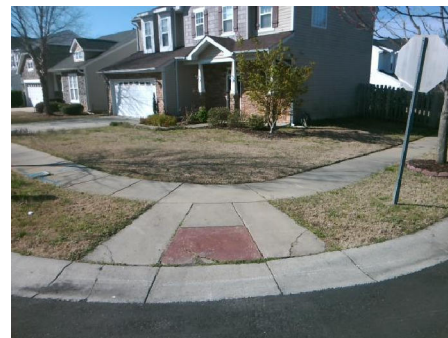
| ADA ID: CA7BCB78F6B6 | Ramp Type: BlendTrans1 | Initial Pass/Fail: Fail | Overall Compliance: No |

DAMAGED RAMP

R304.5.1

| Compliance | Description | Data | Compliance | Description | Data |
|---|---|---|---|---|---|
| No | Ramp Width (in) | 25.0 | Yes | BlendTrans XSlope (%) | 0.9 |

Remove & Replace Curb Ramp With Two New Directional Ramps or Equivalent.
