# Access Compliance Report

## Public Rights-of-Way

### (Curb Ramps)

Intersection ID: 10025543	Main Street: E_TRADE_ST	Cross Street: N/A	Location: SW
ADA ID: CA7F2F3C1900	Ramp Type: BlendTrans1	Initial Pass/Fail: Fail	Overall Compliance: No
Codes/Mitigation Info/Possible Solution		Field Measurements/Component Compliance	
Severity Score: 12.5

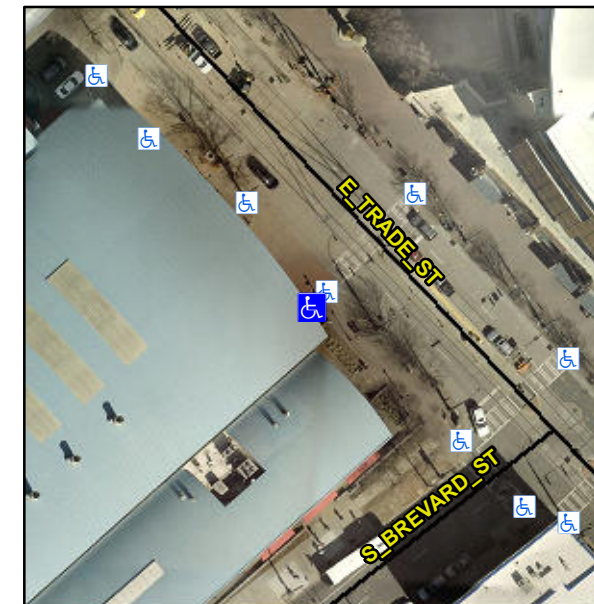
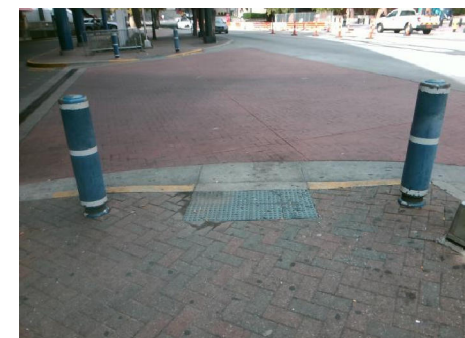
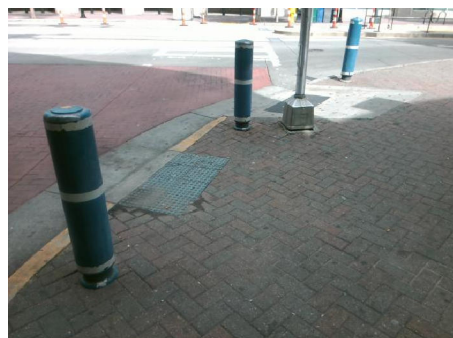
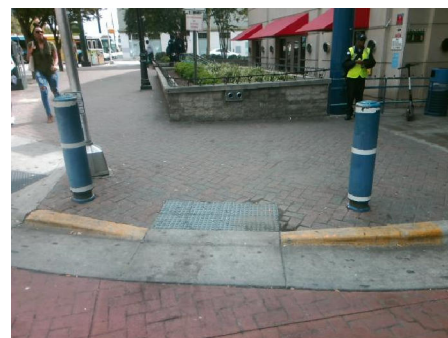
Compliance	Description	Data	Compliance	Description	Data
N/A	Ramp Length (in)	68.0	Yes	BlendTrans Slope (%)	2.9
Yes	Ramp Width (in)	48.0	No	BlendTrans XSlope (%)	6.3
N/A	Flare Type LT	N/A	N/A	Flare Type RT	N/A
N/A	Flare Slope LT (%)	N/A	N/A	Flare Slope RT (%)	N/A
N/A	Flare Traversable LT?	N/A	N/A	Flare Traversable RT?	N/A
N/A	Landing Length (in)	N/A	N/A	DWS Provided?	N/A
N/A	Landing Width (in)	N/A	N/A	DWS Contrast?	N/A
N/A	Landing Slope (%)	N/A	N/A	DWS Length (in)	N/A
N/A	Landing X Slope (%)	N/A	N/A	DWS Full Width?	N/A
N/A	Landing Curb? (Y/N)	N/A	N/A	DWS Offset (in)	N/A
N/A	Shared Landing?	N/A			
N/A	Gutter Ponding?	N/A	N/A	Gutter Slope (%)	N/A
N/A	Gutter Lip Ht (in)	N/A	N/A	Gutter X Slope (%)	N/A
N/A	Painted X Walk1?	No	N/A	Painted X Walk2?	N/A
	X Walk 1 Direction	To W		X Walk 2 Direction	N/A
	X Walk 1 Width (in)	N/A		X Walk 2 Width (in)	N/A
	X Walk 1 Slope (%)	1.7		X Walk 2 Slope (%)	N/A
	X Walk 1 X Slope (%)	4.4		X Walk 2 X Slope (%)	N/A

N/A	Ramp inside XWalk1?	N/A	N/A	Ramp inside XWalk2?	N/A
	Road Slope (%)	4.4		Clear Space?	N/A
	Road X Slope (%)	1.7	N/A	Clear Space to XWalk (in)	N/A
N/A	Any Obstructions?	N/A	N/A	Storm Grate/Utility Hazard?	N/A
	Obstruction Type			Storm Grate/Utility Type	
		N/A			N/A
			Yes	Surface Condition? (G/P)	Good
			N/A	Curb Slope (%)	0.1

Possible Solutions:

**Remove & Replace Curb Ramp With Two New Directional Ramps or Equivalent.**

**R304.5.3**
