Access Compliance Report

Public Rights-of-Way

(Curb Ramps)

Intersection ID: 11992	Main Street: W_MOREHEAD_ST	Cross Street: GRANDIN_RD	Location: NW
ADA ID: CA8EB7882180	Ramp Type: Perp	Initial Pass/Fail: Fail	Overall Compliance: No
		Severity Score: 12.5

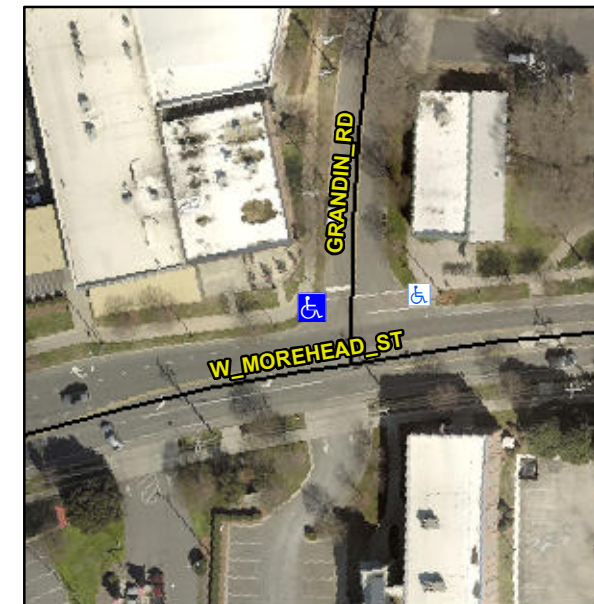
Not Found, R304.2.2

Compliance	Description	Data	Compliance	Description	Data
N/A	Ramp Length (in)	59.0	No	Ramp Slope (%)	8.6
Yes	Ramp Width (in)	48.0	Yes	Ramp XSlope (%)	0.2
N/A	Flare Type LT	N/A	N/A	Flare Type RT	N/A
N/A	Flare Slope LT (%)	N/A	N/A	Flare Slope RT (%)	N/A
N/A	Flare Traversable LT?	N/A	N/A	Flare Traversable RT?	N/A
N/A	Landing Length (in)	N/A	N/A	DWS Provided?	N/A
N/A	Landing Width (in)	N/A	N/A	DWS Contrast?	N/A
N/A	Landing Slope (%)	N/A	N/A	DWS Length (in)	N/A
N/A	Landing X Slope (%)	N/A	N/A	DWS Full Width?	N/A
N/A	Landing Curb? (Y/N)	N/A	N/A	DWS Offset (in)	N/A
N/A	Shared Landing?	N/A			
N/A	Gutter Ponding?	N/A	N/A	Gutter Slope (%)	N/A
N/A	Gutter Lip Ht (in)	N/A	N/A	Gutter X Slope (%)	N/A
N/A	Painted X Walk1?	Yes	N/A	Painted X Walk2?	N/A
	X Walk 1 Direction	To E		X Walk 2 Direction	N/A
N/A	X Walk 1 Width (in)	100.0	N/A	X Walk 2 Width (in)	N/A
	X Walk 1 Slope (%)	0.6		X Walk 2 Slope (%)	N/A
	X Walk 1 X Slope (%)	3.1		X Walk 2 X Slope (%)	N/A

N/A	Ramp inside XWalk1?	Yes	N/A	Ramp inside XWalk2?	N/A
	Road Slope (%)	N/A	N/A	Clear Space?	N/A
	Road X Slope (%)	N/A	N/A	Clear Space to XWalk (in)	N/A
N/A	Any Obstructions?	N/A	N/A	Storm Grate/Utility Hazard?	N/A
	Obstruction Type			Storm Grate/Utility Type	
		N/A			N/A
			Yes	Surface Condition? (G/P)	Good

Possible Solutions:

Remove & Replace Entire Ramp.

Total Cost: \$ 1850.00
