# Access Compliance Report

## Public Rights-of-Way

### (Curb Ramps)

Intersection ID: 30559	Main Street: GREENCREEK_DR	Cross Street: FALLING_MEADOWS_LN	Location: SW
ADA ID: CA98A8C9EC41	Ramp Type: Perp	Initial Pass/Fail: Fail	Overall Compliance: No
Severity Score: 12.5			
Codes/Mitigation Info/Possible Solution		Field Measurements/Component Compliance

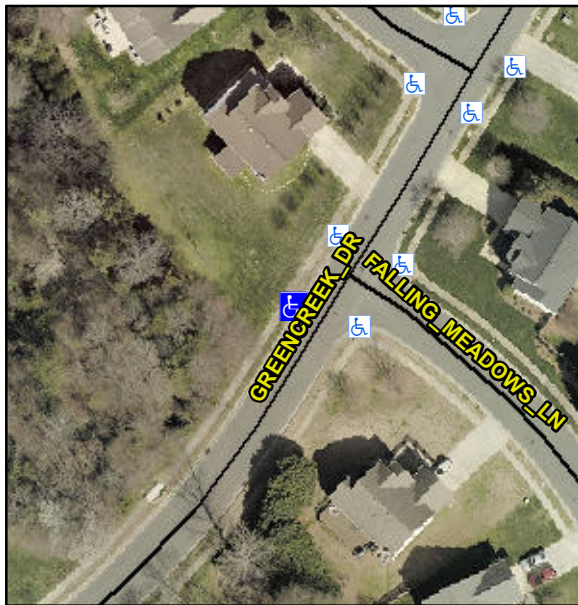
**Not Found, R304.2.2**

Compliance	Description	Data	Compliance	Description	Data
N/A	Ramp Length (in)	48.0	No	Ramp Slope (%)	11.2
Yes	Ramp Width (in)	48.0	Yes	Ramp XSlope (%)	0.8
N/A	Flare Type LT	N/A	N/A	Flare Type RT	N/A
N/A	Flare Slope LT (%)	N/A	N/A	Flare Slope RT (%)	N/A
N/A	Flare Traversable LT?	N/A	N/A	Flare Traversable RT?	N/A
N/A	Landing Length (in)	N/A	N/A	DWS Provided?	N/A
N/A	Landing Width (in)	N/A	N/A	DWS Contrast?	N/A
N/A	Landing Slope (%)	N/A	N/A	DWS Length (in)	N/A
N/A	Landing X Slope (%)	N/A	N/A	DWS Full Width?	N/A
N/A	Landing Curb? (Y/N)	N/A	N/A	DWS Offset (in)	N/A
N/A	Shared Landing?	N/A			
N/A	Gutter Ponding?	N/A	N/A	Gutter Slope (%)	N/A
N/A	Gutter Lip Ht (in)	N/A	N/A	Gutter X Slope (%)	N/A
N/A	Painted X Walk1?	No	N/A	Painted X Walk2?	N/A
	X Walk 1 Direction	To SE		X Walk 2 Direction	N/A
N/A	X Walk 1 Width (in)	N/A	N/A	X Walk 2 Width (in)	N/A
	X Walk 1 Slope (%)	3.3		X Walk 2 Slope (%)	N/A
	X Walk 1 X Slope (%)	1.4		X Walk 2 X Slope (%)	N/A

**Remove & Replace Entire Ramp.**
