Access Compliance Report

Public Rights-of-Way

(Curb Ramps)

Intersection ID: 13994	Main Street: E_3RD_ST	Cross Street: S_TORRENCE_ST	Location: SE
ADA ID: CA9A111C94A5	Ramp Type: Perp	Initial Pass/Fail: Fail	Overall Compliance: No
Severity Score: 8.75			
Codes/Mitigation Info/Possible Solution		Field Measurements/Component Compliance

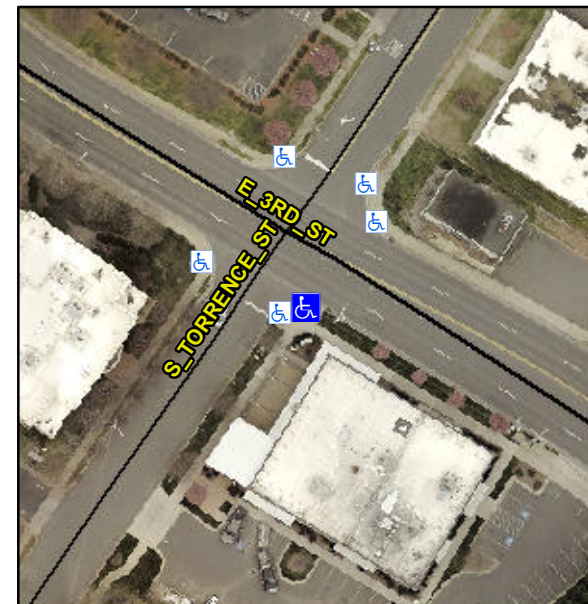
Not Found, R304.5.1

Compliance	Description	Data	Compliance	Description	Data
N/A	Ramp Length (in)	83.0	Yes	Ramp Slope (%)	7.1
No	Ramp Width (in)	36.0	Yes	Ramp XSlope (%)	0.5
N/A	Flare Type LT	N/A	N/A	Flare Type RT	N/A
N/A	Flare Slope LT (%)	N/A	N/A	Flare Slope RT (%)	N/A
N/A	Flare Traversable LT?	N/A	N/A	Flare Traversable RT?	N/A
N/A	Landing Length (in)	N/A	N/A	DWS Provided?	N/A
N/A	Landing Width (in)	N/A	N/A	DWS Contrast?	N/A
N/A	Landing Slope (%)	N/A	N/A	DWS Length (in)	N/A
N/A	Landing X Slope (%)	N/A	N/A	DWS Full Width?	N/A
N/A	Landing Curb? (Y/N)	N/A	N/A	DWS Offset (in)	N/A
N/A	Shared Landing?	N/A			
N/A	Gutter Ponding?	N/A	N/A	Gutter Slope (%)	N/A
N/A	Gutter Lip Ht (in)	N/A	N/A	Gutter X Slope (%)	N/A
N/A	Painted X Walk1?	No	N/A	Painted X Walk2?	N/A
	X Walk 1 Direction	To NE		X Walk 2 Direction	N/A
N/A	X Walk 1 Width (in)	N/A	N/A	X Walk 2 Width (in)	N/A
	X Walk 1 Slope (%)	0.0		X Walk 2 Slope (%)	N/A
	X Walk 1 X Slope (%)	1.7		X Walk 2 X Slope (%)	N/A

N/A	Ramp inside XWalk1?	N/A	N/A	Ramp inside XWalk2?	N/A
	Road Slope (%)	N/A	N/A	Clear Space?	N/A
	Road X Slope (%)	N/A	N/A	Clear Space to XWalk (in)	N/A
N/A	Any Obstructions?	N/A	N/A	Storm Grate/Utility Hazard?	N/A
	Obstruction Type			Storm Grate/Utility Type	
		N/A			N/A
			Yes	Surface Condition? (G/P)	Good

Possible Solutions:

Remove & Replace Entire Ramp.
