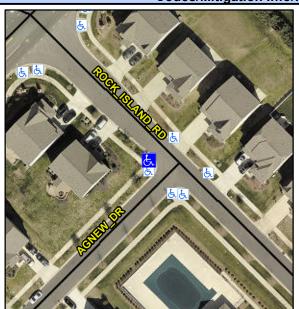
Intersection ID: N/AMain Street:ROCK_ISLAND_RDCross Street:AGNEW_DRLocation:WADA ID: CA9A900741AFRamp Type:BlendTrans1Initial Pass/Fail:FailOverall Compliance:NoSeverity Score:21.25

Field Measurements/Component Compliance						
Comp	Compliance Description Data		Comp	liance Description	Data	
N/A	Ramp Length (in)	102.0	Yes	BlendTrans Slope (%)	2.0	
No	Ramp Width (in)	47.8	No	BlendTrans XSlope (%)	6.8	
N/A	Flare Type LT	N/A	N/A	Flare Type RT	N/A	
N/A	Flare Slope LT (%)	N/A	N/A	Flare Slope RT (%)	N/A	
N/A	Flare Traversable LT?	N/A	N/A	Flare Traversable RT?	N/A	
N/A	Landing Length (in)	N/A	N/A	DWS Provided?	N/A	
N/A	Landing Width (in)	N/A	N/A	DWS Contrast?	N/A	
N/A	Landing Slope (%)	N/A	N/A	DWS Length (in)	N/A	
N/A	Landing X Slope (%)	N/A	N/A	DWS Full Width?	N/A	
N/A	Landing Curb? (Y/N)	N/A	N/A	DWS Offset (in)	N/A	
N/A	Shared Landing?	N/A				
N/A	Gutter Ponding?	N/A	N/A	Gutter Slope (%)	N/A	
N/A	Gutter Lip Ht (in)	N/A	N/A	Gutter X Slope (%)	N/A	
N/A	Painted X Walk1?	No	N/A	Painted X Walk2?	N/A	
	X Walk 1 Direction	To NE		X Walk 2 Direction	N/A	
	X Walk 1 Width (in)	N/A		X Walk 2 Width (in)	N/A

X Walk 1 Slope (%)	3.1		X Walk 2 Slope (%)	N/A	
	X Walk 1 X Slope (%)	8.4		X Walk 2 X Slope (%)	N/A	
N/A	Ramp inside XWalk1?	N/A	N/A	Ramp inside XWalk2?	N/A	
	Road Slope (%)	8.4		Clear Space?	N/A	
	Road X Slope (%)	3.1	N/A	Clear Space to XWalk (in)	N/A	
N/A	Any Obstructions?	N/A	N/A	Storm Grate/Utility Hazard?	N/A	
	Obstruction Type		l	Storm Grate/Utility Type		
		N/A	l		N/A	
			Yes	Surface Condition? (G/P)	Good	
			N/A	Curb Slope (%)	4.0

Remove & Replace Curb Ramp With
Two New Directional Ramps or
Equivalent.
