## Access Compliance Report Public Rights-of-Way (Curb Ramps)

Intersection ID: 18461 Main Street: SHARON\_FOREST\_DR Cross Street: WALLACE\_RD Location: E

ADA ID: CA9BA36B3B38 Ramp Type: PerpDiag Initial Pass/Fail: Fail Overall Compliance: No Severity Score: 13.75

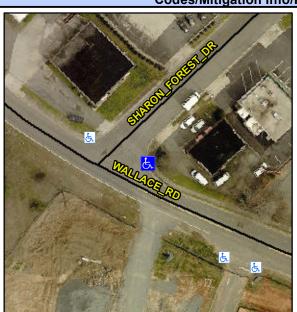
Not Found, R304.2.2, R304.5.3

ried Measurements/Component Comphance							
	Compliance Description		Data	Comp	liance Desc	Description	
	N/A	Ramp Length (in)	74.0	No	Ramp Slop	e (%)	8.9
	Yes	Ramp Width (in)	48.0	No	Ramp XSIo	pe (%)	3.8
	N/A	Flare Type LT	N/A	N/A	Flare Type	RT	N/A
	N/A	Flare Slope LT (%)	N/A	N/A	Flare Slope	e RT (%)	N/A
	N/A	Flare Traversable LT?	N/A	N/A	Flare Trave	ersable RT?	N/A
	N/A	Landing Length (in)	N/A	N/A	DWS Provi	ded?	N/A
	N/A	Landing Width (in)	N/A	N/A	DWS Contr	rast?	N/A
	N/A	Landing Slope (%)	N/A	N/A	DWS Leng	th (in)	N/A
	N/A	Landing X Slope (%)	N/A	N/A	DWS Full V	Vidth?	N/A
	N/A	Landing Curb? (Y/N)	N/A	N/A	DWS Offse	t (in)	N/A
	N/A	Shared Landing?	N/A				
	N/A	Gutter Ponding?	N/A	N/A	Gutter Slop	oe (%)	N/A
	N/A	Gutter Lip Ht (in)	N/A	N/A	Gutter X SI	ope (%)	N/A
	N/A	Painted X Walk1?	No	N/A	Painted X \	Nalk2?	No
		X Walk 1 Direction	To NW		X Walk 2 D	irection	To SW
	N/A	X Walk 1 Width (in)	N/A	N/A	X Walk 2 W	/idth (in)	N/A

X Walk 1 Slope (%)	5.8		X Walk 2 S	lope (%)	7.2
		X Walk 1 X Slope (%)	6.5		X Walk 2 X	Slope (%)	4.2
	N/A	Ramp inside XWalk1?	N/A	N/A	Ramp insid	le XWalk2?	N/A
		Road Slope (%)	4.2	N/A	Clear Spac	e?	N/A
		Road X Slope (%)	7.7	N/A	Clear Spac	e to XWalk (in)	N/A
	N/A	Any Obstructions?	N/A	N/A	Storm Grat	e/Utility Hazard?	N/A

Remove & Replace Curb Ramp With Two New Directional Ramps or Equivalent.

Total Cost: \$ 3200.00
