## **Access Compliance Report Public Rights-of-Way** (Curb Ramps)

Intersection ID: 16020 Main Street: MONROE\_RD **Cross Street: COMMONWEALTH AV** Location: NE ADA ID: CA9E9FB53D53 Ramp Type: PerpDiag Initial Pass/Fail: Fail **Overall Compliance: No Severity Score:** 8.75

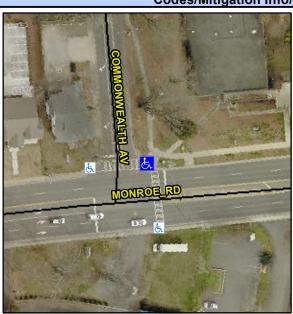
Field Measurements/Component Compliance					
Compliance Description Date		Data	Comp	liance Description	Data
N/A	Ramp Length (in)	149.0	Yes	Ramp Slope (%)	6.3
No	Ramp Width (in)	37.0	Yes	Ramp XSlope (%)	0.4
N/A	Flare Type LT	N/A	N/A	Flare Type RT	N/A
N/A	Flare Slope LT (%)	N/A	N/A	Flare Slope RT (%)	N/A
N/A	Flare Traversable LT?	N/A	N/A	Flare Traversable RT?	N/A
N/A	Landing Length (in)	N/A	N/A	DWS Provided?	N/A
N/A	Landing Width (in)	N/A	N/A	DWS Contrast?	N/A
N/A	Landing Slope (%)	N/A	N/A	DWS Length (in)	N/A
N/A	Landing X Slope (%)	N/A	N/A	DWS Full Width?	N/A
N/A	Landing Curb? (Y/N)	N/A	N/A	DWS Offset (in)	N/A
N/A	Shared Landing?	N/A			
N/A	Gutter Ponding?	N/A	N/A	Gutter Slope (%)	N/A
N/A	Gutter Lip Ht (in)	N/A	N/A	Gutter X Slope (%)	N/A
N/A	Painted X Walk1?	Yes	N/A	Painted X Walk2?	Yes
	X Walk 1 Direction	To W		X Walk 2 Direction	To S
N/A	X Walk 1 Width (in)	115.0	N/A	X Walk 2 Width (in)	77.0
	X Walk 1 Slope (%)	2.1		X Walk 2 Slope (%)	3.0

X Walk 1 X Slope (%)	1.0		X Walk 2 X Slope (%)	0.8
N/A	Ramp inside XWalk1?	Yes	N/A	Ramp inside XWalk2?	No
	Road Slope (%)	1.6	N/A	Clear Space?	N/A
	Road X Slope (%)	2.6	N/A	Clear Space to XWalk (in)	N/A
N/A	Any Obstructions?	N/A	N/A	Storm Grate/Utility Hazard?	N/A
	Obstruction Type			Storm Grate/Utility Type	
		N/A			N/A
			Yes	Surface Condition? (G/P)	Good
7	119

Possible Solutions: Remove & Replace Curb Ramp With **Two New Directional Ramps or Equivalent. Restripe Crosswalk.** Surveyor Notes: N/A PROW/ADA: Not Found, R304.5.1
