Access Compliance Report

Public Rights-of-Way

(Curb Ramps)

Intersection ID: 9686	Main Street: N_TRYON_ST	Cross Street: W_31ST_ST	Location: W
ADA ID: CA9F49FE04F6	Ramp Type: PerpDiag	Initial Pass/Fail: Fail	Overall Compliance: No
Severity Score: 22.5			
Codes/Mitigation Info/Possible Solution		Field Measurements/Component Compliance

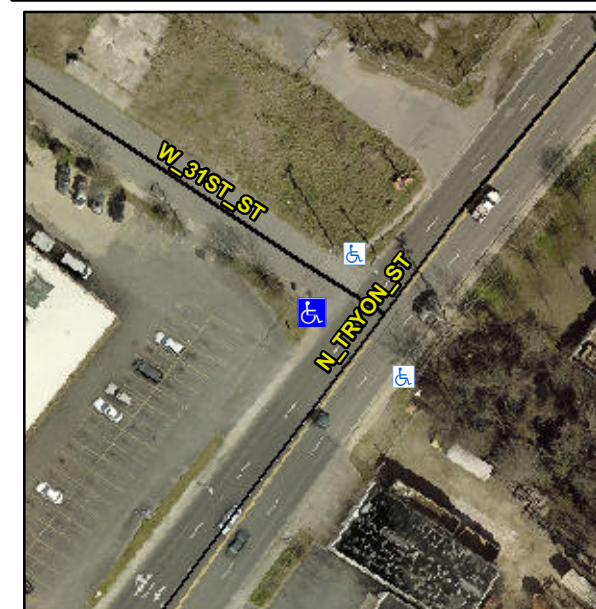
Not Found, R304.5.1, R304.2.2, R304.5.3

Compliance	Description	Data	Compliance	Description	Data
N/A	Ramp Length (in)	62.5	No	Ramp Slope (%)	8.8
No	Ramp Width (in)	41.0	No	Ramp XSlope (%)	2.6
N/A	Flare Type LT	N/A	N/A	Flare Type RT	N/A
N/A	Flare Slope LT (%)	N/A	N/A	Flare Slope RT (%)	N/A
N/A	Flare Traversable LT?	N/A	N/A	Flare Traversable RT?	N/A
N/A	Landing Length (in)	N/A	N/A	DWS Provided?	N/A
N/A	Landing Width (in)	N/A	N/A	DWS Contrast?	N/A
N/A	Landing Slope (%)	N/A	N/A	DWS Length (in)	N/A
N/A	Landing X Slope (%)	N/A	N/A	DWS Full Width?	N/A
N/A	Landing Curb? (Y/N)	N/A	N/A	DWS Offset (in)	N/A
N/A	Shared Landing?	N/A			
N/A	Gutter Ponding?	N/A	N/A	Gutter Slope (%)	N/A
N/A	Gutter Lip Ht (in)	N/A	N/A	Gutter X Slope (%)	N/A
N/A	Painted X Walk1?	No	N/A	Painted X Walk2?	No
	X Walk 1 Direction	To SE		X Walk 2 Direction	To NE
N/A	X Walk 1 Width (in)	N/A	N/A	X Walk 2 Width (in)	N/A
	X Walk 1 Slope (%)	3.3		X Walk 2 Slope (%)	4.1
	X Walk 1 X Slope (%)	0.5		X Walk 2 X Slope (%)	3.3

N/A	Ramp inside XWalk1?	N/A	N/A	Ramp inside XWalk2?	N/A
	Road Slope (%)	2.0	N/A	Clear Space?	N/A
	Road X Slope (%)	5.9	N/A	Clear Space to XWalk (in)	N/A
N/A	Any Obstructions?	N/A	N/A	Storm Grate/Utility Hazard?	N/A
	Obstruction Type			Storm Grate/Utility Type	
		N/A			N/A
			Yes	Surface Condition? (G/P)	Good

Possible Solutions:

Remove & Replace Curb Ramp With Two New Directional Ramps or Equivalent.
