# Access Compliance Report

## Public Rights-of-Way

### (Curb Ramps)

Intersection ID: 12400	Main Street: BELVEDERE_AV	Cross Street: ST_ANDREWS_LN	Location: SW
ADA ID: CAB71B31EE04	Ramp Type: Perp	Initial Pass/Fail: Fail	Overall Compliance: No
Severity Score: 8.75			
Codes/Mitigation Info/Possible Solution		Field Measurements/Component Compliance

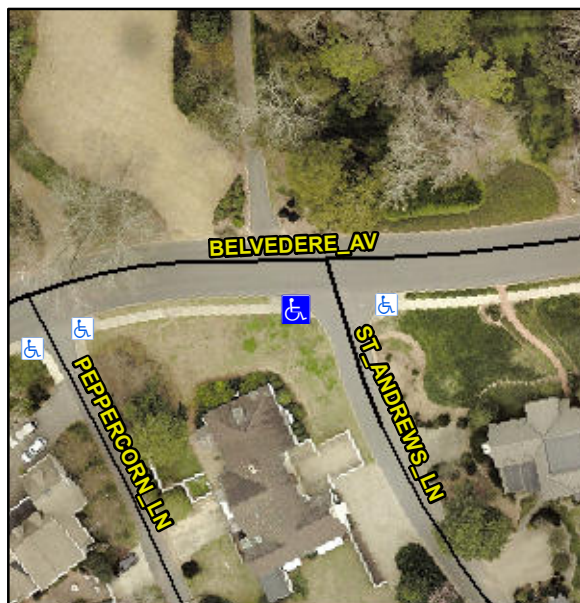
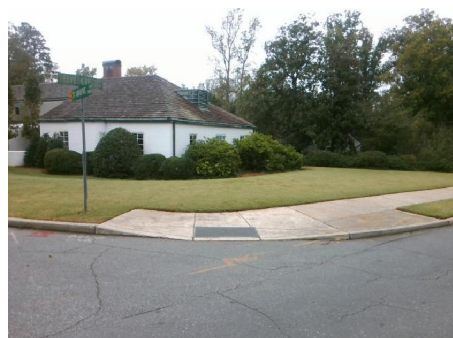
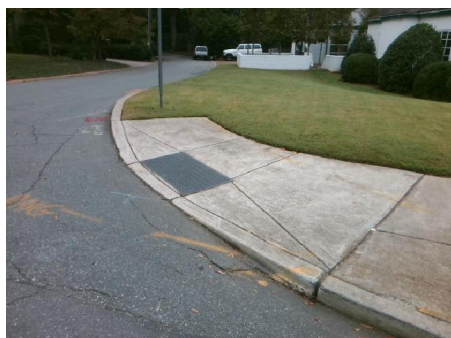
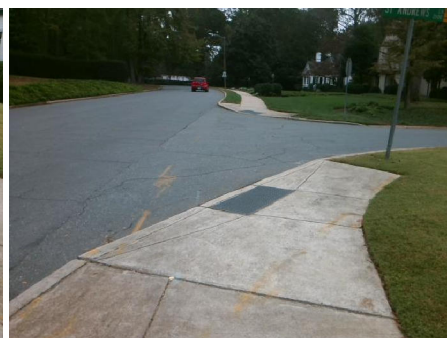
Compliance	Description	Data	Compliance	Description	Data
N/A	Ramp Length (in)	66.5	Yes	Ramp Slope (%)	7.2
No	Ramp Width (in)	40.0	Yes	Ramp XSlope (%)	1.3
N/A	Flare Type LT	N/A	N/A	Flare Type RT	N/A
N/A	Flare Slope LT (%)	N/A	N/A	Flare Slope RT (%)	N/A
N/A	Flare Traversable LT?	N/A	N/A	Flare Traversable RT?	N/A
N/A	Landing Length (in)	N/A	N/A	DWS Provided?	N/A
N/A	Landing Width (in)	N/A	N/A	DWS Contrast?	N/A
N/A	Landing Slope (%)	N/A	N/A	DWS Length (in)	N/A
N/A	Landing X Slope (%)	N/A	N/A	DWS Full Width?	N/A
N/A	Landing Curb? (Y/N)	N/A	N/A	DWS Offset (in)	N/A
N/A	Shared Landing?	N/A			
N/A	Gutter Ponding?	N/A	N/A	Gutter Slope (%)	N/A
N/A	Gutter Lip Ht (in)	N/A	N/A	Gutter X Slope (%)	N/A
N/A	Painted X Walk1?	No	N/A	Painted X Walk2?	N/A
	X Walk 1 Direction	To E		X Walk 2 Direction	N/A
N/A	X Walk 1 Width (in)	N/A	N/A	X Walk 2 Width (in)	N/A
	X Walk 1 Slope (%)	3.8		X Walk 2 Slope (%)	N/A
	X Walk 1 X Slope (%)	1.2		X Walk 2 X Slope (%)	N/A

N/A	Ramp inside XWalk1?	N/A	N/A	Ramp inside XWalk2?	N/A
	Road Slope (%)	N/A	N/A	Clear Space?	N/A
	Road X Slope (%)	N/A	N/A	Clear Space to XWalk (in)	N/A
N/A	Any Obstructions?	N/A	N/A	Storm Grate/Utility Hazard?	N/A
	Obstruction Type			Storm Grate/Utility Type	
		N/A			N/A
			Yes	Surface Condition? (G/P)	Good

**Remove & Replace Entire Ramp.**

**R304.5.1**
