| Intersection ID: 44786 | Main Street: AYRSLEY_TOWN_BV | Cross Street: KINGS_PARADE_BV | Location: | SW |
| ADA ID: CABCFE756938 | Ramp Type: Perp | Initial Pass/Fail: Fail | Overall Compliance: No | Severity Score: 12.5 |

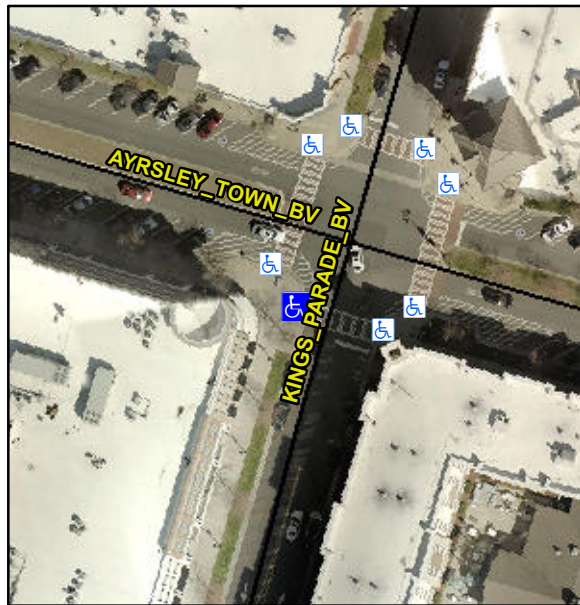
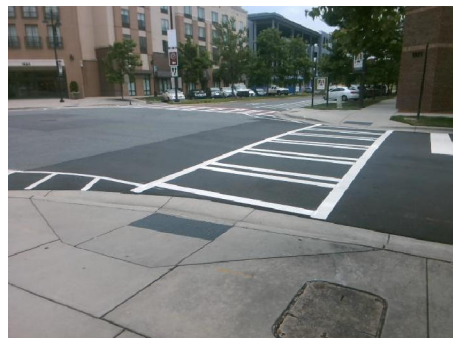
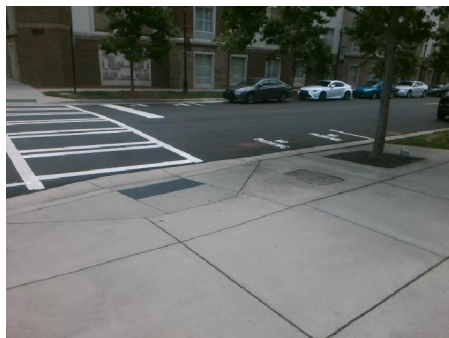
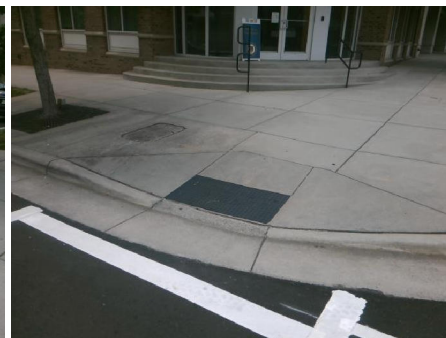
Not Found, R304.2.2

| Compliance | Description | Data | Compliance | Description | Data |
|---|---|---|---|---|---|
| N/A | Ramp Length (in) | 60.0 | No | Ramp Slope (%) | 11.9 |

Remove & Replace Entire Ramp.

Total Cost: \$ 1850.00
