# Access Compliance Report

## Public Rights-of-Way

### (Curb Ramps)

Intersection ID: 28615	Main Street: CARDINAL_GLEN_CT	Cross Street: KESTRAL_RIDGE_DR	Location: SE
ADA ID: CABE2E1559A9	Ramp Type: BlendTrans1	Initial Pass/Fail: Fail	Overall Compliance: No
Severity Score: 8.75			
Codes/Mitigation Info/Possible Solution		Field Measurements/Component Compliance

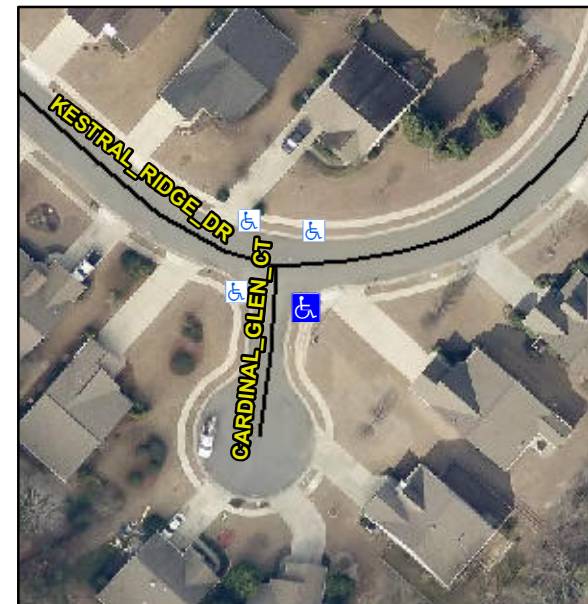
**Not Found, R304.5.1**

**Remove & Replace Curb Ramp With Two New Directional Ramps or Equivalent.**

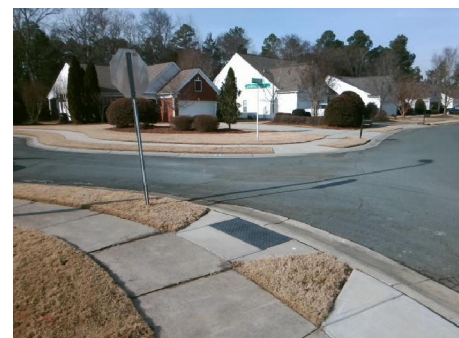
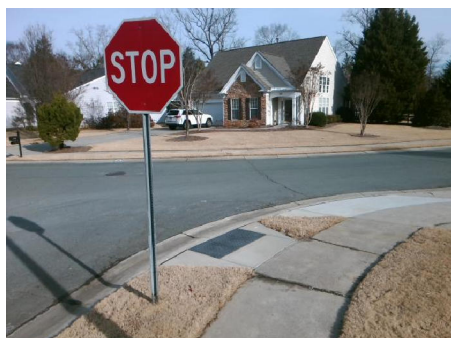
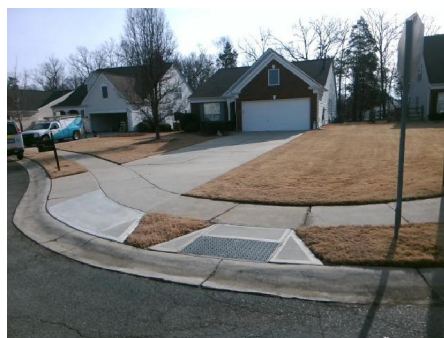
Compliance	Description	Data	Compliance	Description	Data
N/A	Ramp Length (in)	48.0	Yes	BlendTrans Slope (%)	1.0
No	Ramp Width (in)	47.0	Yes	BlendTrans XSlope (%)	1.0
N/A	Flare Type LT	N/A	N/A	Flare Type RT	N/A
N/A	Flare Slope LT (%)	N/A	N/A	Flare Slope RT (%)	N/A
N/A	Flare Traversable LT?	N/A	N/A	Flare Traversable RT?	N/A
N/A	Landing Length (in)	N/A	N/A	DWS Provided?	N/A
N/A	Landing Width (in)	N/A	N/A	DWS Contrast?	N/A
N/A	Landing Slope (%)	N/A	N/A	DWS Length (in)	N/A
N/A	Landing X Slope (%)	N/A	N/A	DWS Full Width?	N/A
N/A	Landing Curb? (Y/N)	N/A	N/A	DWS Offset (in)	N/A
N/A	Shared Landing?	N/A			
N/A	Gutter Ponding?	N/A	N/A	Gutter Slope (%)	N/A
N/A	Gutter Lip Ht (in)	N/A	N/A	Gutter X Slope (%)	N/A
N/A	Painted X Walk1?	No	N/A	Painted X Walk2?	No
	X Walk 1 Direction	To W		X Walk 2 Direction	To N
	X Walk 1 Width (in)	N/A		X Walk 2 Width (in)	N/A
	X Walk 1 Slope (%)	0.3		X Walk 2 Slope (%)	1.2
	X Walk 1 X Slope (%)	0.2		X Walk 2 X Slope (%)	0.2

N/A	Ramp inside XWalk1?	N/A	N/A	Ramp inside XWalk2?	N/A
	Road Slope (%)	0.9		Clear Space?	N/A
	Road X Slope (%)	0.7	N/A	Clear Space to XWalk (in)	N/A
N/A	Any Obstructions?	N/A	N/A	Storm Grate/Utility Hazard?	N/A
	Obstruction Type			Storm Grate/Utility Type	
		N/A			N/A
			Yes	Surface Condition? (G/P)	Good
			No	Curb Slope (%)	24.6
