Access Compliance Report

Public Rights-of-Way

(Curb Ramps)

Intersection ID: 10039540	Main Street: THERMAL_RD	Cross Street: N/A	Location: SW
ADA ID: CAC0AEC01268	Ramp Type: Directional1	Initial Pass/Fail: Fail	Overall Compliance: No
			Severity Score: 33.75

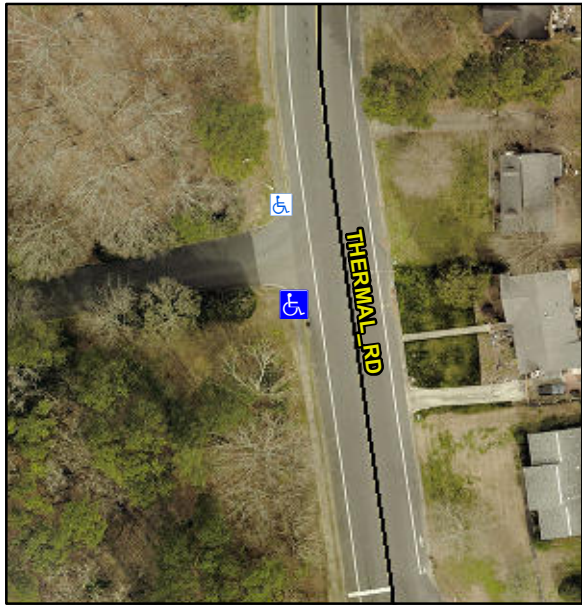
Possible Solutions:		Compliance			Description			Data		Compliance			Description			Data					
	Remove & Replace Entire Ramp.		N/A	Ramp Length (in)		55.0		N/A	Grade Break?		N/A		N/A	Grade Break Slope (%)		0.0		N/A	Grade Break XSlope (%)		0.0	
			No	Ramp Width (in)		47.5		N/A	Grade Break Slope (%)		0.0		N/A	Grade Break XSlope (%)		0.0						
			Yes	Ramp Slope (%)		2.6		N/A	Grade Break XSlope (%)		0.0											
			No	Ramp XSlope (%)		8.1																
			N/A	Flare Type LT		N/A		N/A	Flare Type RT		N/A											
			N/A	Flare Slope LT (%)		N/A		N/A	Flare Slope RT (%)		0.0											
			N/A	Flare Traversable LT?		N/A		N/A	Flare Traversable RT?		N/A											
			N/A	Landing Length (in)		0.0		N/A	DWS Provided?		N/A											
			N/A	Landing Width (in)		0.0		N/A	DWS Contrast?		N/A											
			N/A	Landing Slope (%)		0.0		N/A	DWS Length (in)		N/A

N/A	Landing X Slope (%)		0.0		N/A	DWS Full Width?		N/A											
			N/A	Landing Curb? (Y/N)		N/A		N/A	DWS Offset LT (in)		N/A											
			N/A	Shared Landing?		N/A		N/A	DWS Offset RT (in)		N/A											
			N/A	Gutter Ponding?		0.0		N/A	Gutter Slope (%)		N/A											
			N/A	Gutter Lip Ht (in)		0.0		N/A	Gutter X Slope (%)		N/A											
			N/A	Painted X Walk1?		No		Road Slope (%)		2.3												
				X Walk 1 Direction		To NW		Road X Slope (%)		6.0												
				X Walk 1 Width (in)		N/A		Clear Space?		N/A												
				X Walk 1 Slope (%)		2.3		N/A	Clear Space to XWalk (in)		N/A											
				X Walk 1 X Slope (%)		6.0		N/A	Storm Grate/Utility Hazard?		N/A											
			N/A	Ramp inside XWalk1?		N/A		Storm Grate/Utility Type														
			N/A	Any Obstructions?		N/A				N/A												
				Obstruction Type				Yes	Surface Condition? (G/P)		Good											
								N/A	Curb Slope (%)		6.8

Surveyor Notes:																				
		ASP LIP 1.0", CURB LIP 0.5"																				
		PROW/ADA:																				
		R304.5.1, R304.5.3																				
		Total Cost:		\$	1600.00
