Access Compliance Report

Public Rights-of-Way

(Curb Ramps)

Intersection ID: 28281	Main Street: FAIRHOPE_CT	Cross Street: LANDING_GREEN_DR	Location: NW
ADA ID: CAC534EAD28E	Ramp Type: Perp	Initial Pass/Fail: Pass	Overall Compliance: No
Severity Score: 15			
Codes/Mitigation Info/Possible Solution		Field Measurements/Component Compliance

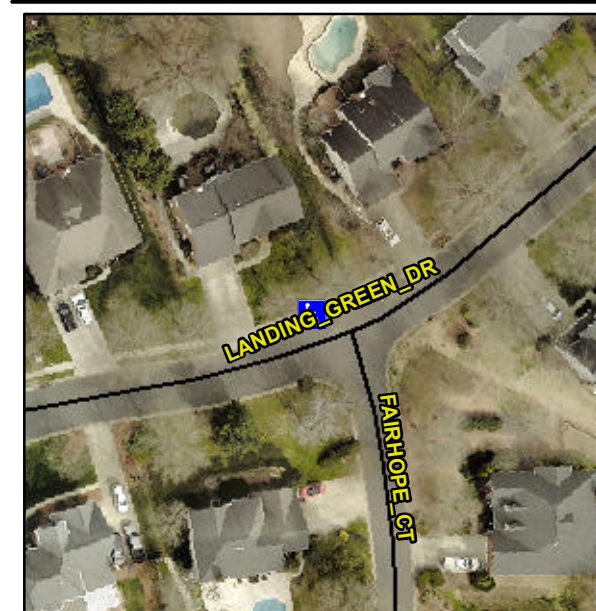
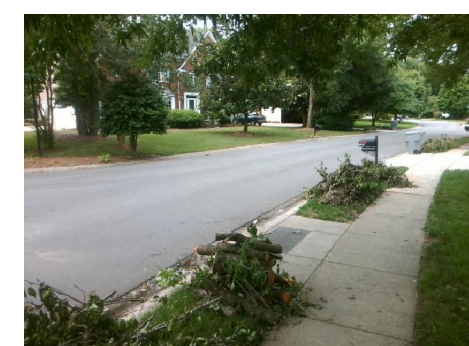
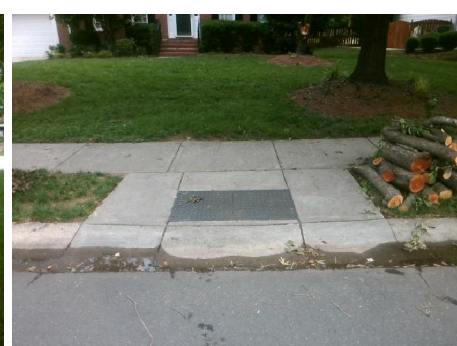
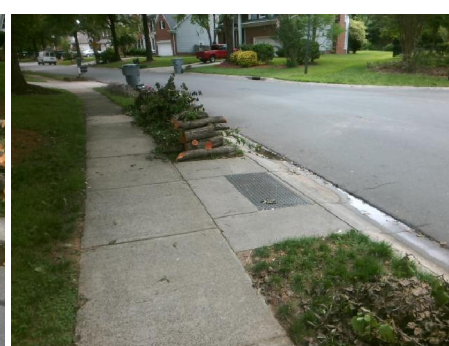
Not Found, R304.2.1, R304.2.2-Perp, R304.3.2-Para, R305.2, R302.7, R302.7.2

Compliance	Description	Data	Compliance	Description	Data
N/A	Ramp Length (in)	49.0	Yes	Ramp Slope (%)	5.9
Yes	Ramp Width (in)	48.0	Yes	Ramp XSlope (%)	0.3
N/A	Flare Type LT	Sloped	N/A	Flare Type RT	N/A
N/A	Flare Slope LT (%)	2.2	Yes	Flare Slope RT (%)	3.0
N/A	Flare Traversable LT?	Yes	N/A	Flare Traversable RT?	Yes
No	Landing Length (in)	47.0	Yes	DWS Provided?	Yes
Yes	Landing Width (in)	48.0	Yes	DWS Contrast?	Yes
No	Landing Slope (%)	3.8	Yes	DWS Length (in)	24.5
Yes	Landing X Slope (%)	1.0	Yes	DWS Full Width?	Yes
N/A	Landing Curb? (Y/N)	No	No	DWS Offset (in)	2.5
N/A	Shared Landing?	No			
No	Gutter Ponding?	Yes	Yes	Gutter Slope (%)	4.0
No	Gutter Lip Ht (in)	1.0	Yes	Gutter X Slope (%)	1.6
N/A	Painted X Walk1?	No	N/A	Painted X Walk2?	N/A
	X Walk 1 Direction	To SW		X Walk 2 Direction	N/A
N/A	X Walk 1 Width (in)	N/A	N/A	X Walk 2 Width (in)	N/A
	X Walk 1 Slope (%)	2.7		X Walk 2 Slope (%)	N/A
	X Walk 1 X Slope (%)	0.9		X Walk 2 X Slope (%)	N/A

N/A	Ramp inside XWalk1?	N/A	N/A	Ramp inside XWalk2?	N/A
	Road Slope (%)	N/A	N/A	Clear Space?	Yes
	Road X Slope (%)	N/A	N/A	Clear Space to XWalk (in)	N/A
Yes	Any Obstructions?	No	Yes	Storm Grate/Utility Hazard?	No
	Obstruction Type			Storm Grate/Utility Type	
		N/A			N/A
			Yes	Surface Condition? (G/P)	Good

Remove & Replace Entire Ramp.
