# Access Compliance Report

## Public Rights-of-Way

### (Curb Ramps)

| Intersection ID: 14844 | Main Street: DILWORTH_RD_WEST | Cross Street: EAST_BV | Location: N |

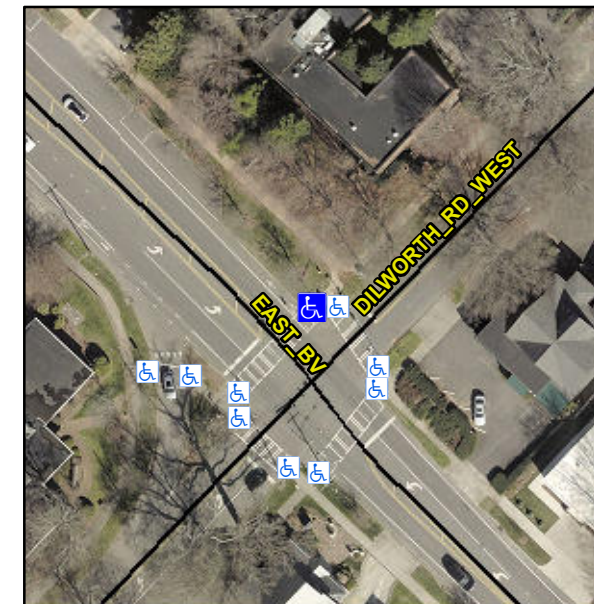
**R304.5.3, R304.2.2-Perp, R304.3.2-Para**

| Compliance | Description | Data | Compliance | Description | Data |
|---|---|---|---|---|---|
| Yes | Ramp Slope (%) | 3.9 | No | Grade Break XSlope (%) | 3.2 |
| No | Ramp XSlope (%) | 2.7 | | | |
| No | Landing Slope (%) | 4.7 | Yes | DWS Length (in) | 24.0 |
| No | Landing X Slope (%) | 2.1 | Yes | DWS Full Width? | Yes |

**Remove & Replace Entire Ramp.**

Total Cost: \$ 1600.00
