Access Compliance Report

Public Rights-of-Way

(Curb Ramps)

Intersection ID: 3237	Main Street: HERITAGE_HILLS_LN	Cross Street: MACKINAC_ST	Location: SW
ADA ID: CACE1BB6EF87	Ramp Type: Perp	Initial Pass/Fail: Fail	Overall Compliance: No
Severity Score: 8.75			
Codes/Mitigation Info/Possible Solution		Field Measurements/Component Compliance

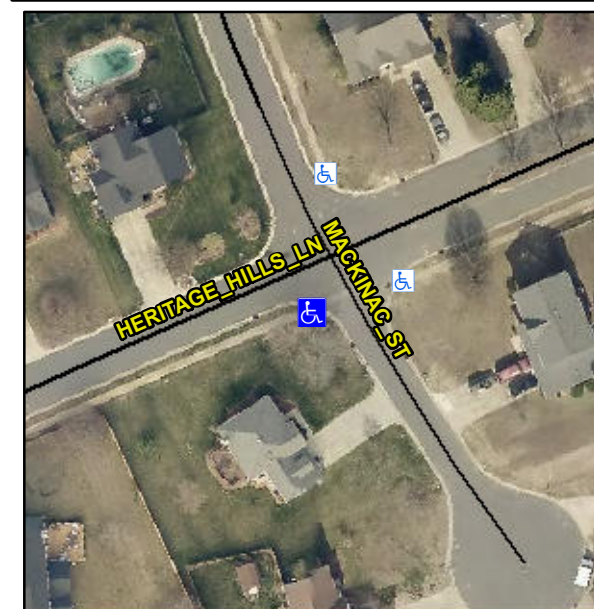
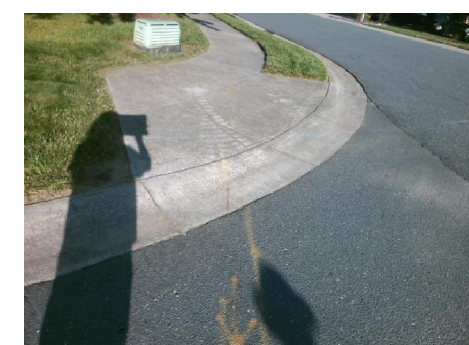
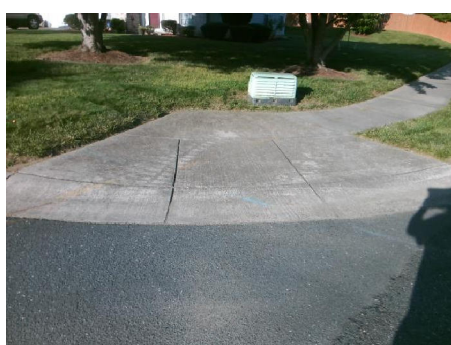
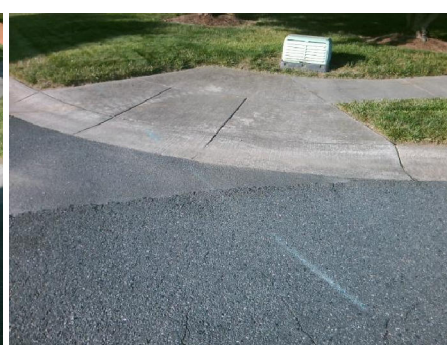
R304.5.1

Compliance	Description	Data	Compliance	Description	Data
N/A	Ramp Length (in)	48.0	Yes	Ramp Slope (%)	8.0
No	Ramp Width (in)	46.5	Yes	Ramp XSlope (%)	0.5
N/A	Flare Type LT	N/A	N/A	Flare Type RT	N/A
N/A	Flare Slope LT (%)	N/A	N/A	Flare Slope RT (%)	N/A
N/A	Flare Traversable LT?	N/A	N/A	Flare Traversable RT?	N/A
N/A	Landing Length (in)	N/A	N/A	DWS Provided?	N/A
N/A	Landing Width (in)	N/A	N/A	DWS Contrast?	N/A
N/A	Landing Slope (%)	N/A	N/A	DWS Length (in)	N/A
N/A	Landing X Slope (%)	N/A	N/A	DWS Full Width?	N/A
N/A	Landing Curb? (Y/N)	N/A	N/A	DWS Offset (in)	N/A
N/A	Shared Landing?	N/A			
N/A	Gutter Ponding?	N/A	N/A	Gutter Slope (%)	N/A
N/A	Gutter Lip Ht (in)	N/A	N/A	Gutter X Slope (%)	N/A
N/A	Painted X Walk1?	No	N/A	Painted X Walk2?	N/A
	X Walk 1 Direction	To E		X Walk 2 Direction	N/A
N/A	X Walk 1 Width (in)	N/A	N/A	X Walk 2 Width (in)	N/A
	X Walk 1 Slope (%)	0.2		X Walk 2 Slope (%)	N/A
	X Walk 1 X Slope (%)	1.3		X Walk 2 X Slope (%)	N/A

N/A	Ramp inside XWalk1?	N/A	N/A	Ramp inside XWalk2?	N/A
	Road Slope (%)	N/A	N/A	Clear Space?	N/A
	Road X Slope (%)	N/A	N/A	Clear Space to XWalk (in)	N/A
N/A	Any Obstructions?	N/A	N/A	Storm Grate/Utility Hazard?	N/A
	Obstruction Type			Storm Grate/Utility Type	
		N/A			N/A
		Yes		Surface Condition? (G/P)	Good

Possible Solutions:

Remove & Replace Entire Ramp.
