# Access Compliance Report

## Public Rights-of-Way

### (Curb Ramps)

Intersection ID: 49925	Main Street: PAXTON_RUN_RD	Cross Street: CAMPBELL_HALL_CT	Location: S
ADA ID: CAE62C2437C7	Ramp Type: Perp	Initial Pass/Fail: Fail	Overall Compliance: No
Codes/Mitigation Info/Possible Solution		Field Measurements/Component Compliance

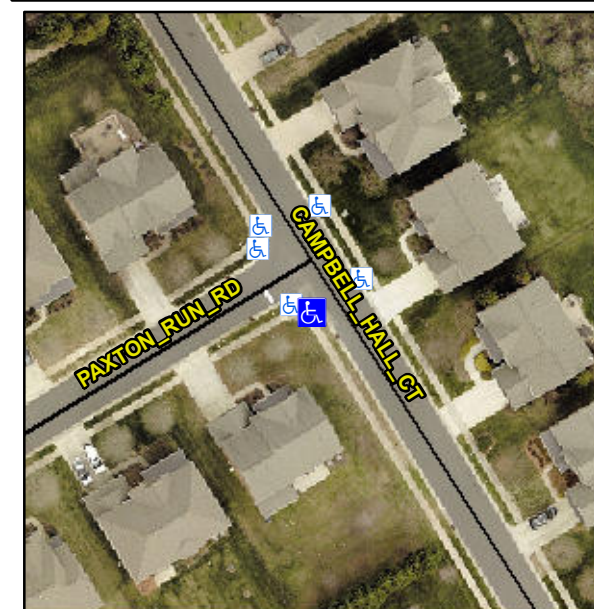
**Not Found, R304.2.2, R304.5.3**

Compliance	Description	Data	Compliance	Description	Data
N/A	Ramp Length (in)	48.0	No	Ramp Slope (%)	10.5
Yes	Ramp Width (in)	48.0	No	Ramp XSlope (%)	2.6
N/A	Flare Type LT	N/A	N/A	Flare Type RT	N/A
N/A	Flare Slope LT (%)	N/A	N/A	Flare Slope RT (%)	N/A
N/A	Flare Traversable LT?	N/A	N/A	Flare Traversable RT?	N/A
N/A	Landing Length (in)	N/A	N/A	DWS Provided?	N/A
N/A	Landing Width (in)	N/A	N/A	DWS Contrast?	N/A
N/A	Landing Slope (%)	N/A	N/A	DWS Length (in)	N/A
N/A	Landing X Slope (%)	N/A	N/A	DWS Full Width?	N/A
N/A	Landing Curb? (Y/N)	N/A	N/A	DWS Offset (in)	N/A
N/A	Shared Landing?	N/A			
N/A	Gutter Ponding?	N/A	N/A	Gutter Slope (%)	N/A
N/A	Gutter Lip Ht (in)	N/A	N/A	Gutter X Slope (%)	N/A
N/A	Painted X Walk1?	No	N/A	Painted X Walk2?	N/A
	X Walk 1 Direction	To NE		X Walk 2 Direction	N/A
N/A	X Walk 1 Width (in)	N/A	N/A	X Walk 2 Width (in)	N/A
	X Walk 1 Slope (%)	2.0		X Walk 2 Slope (%)	N/A
	X Walk 1 X Slope (%)	0.5		X Walk 2 X Slope (%)	N/A

N/A	Ramp inside XWalk1?	N/A	N/A	Ramp inside XWalk2?	N/A
	Road Slope (%)	N/A	N/A	Clear Space?	N/A
	Road X Slope (%)	N/A	N/A	Clear Space to XWalk (in)	N/A
N/A	Any Obstructions?	N/A	N/A	Storm Grate/Utility Hazard?	N/A
	Obstruction Type			Storm Grate/Utility Type	
		N/A			N/A
			Yes	Surface Condition? (G/P)	Good

**Remove & Replace Entire Ramp.**

Total Cost: \$ 1850.00
