Access Compliance Report

Public Rights-of-Way

(Curb Ramps)

Intersection ID: 45733	Main Street: REDWOOD VALLEY LN	Cross Street: DALTREY LN	Location: SE
ADA ID: CAEC5E4F879D	Ramp Type: PerpDiag	Initial Pass/Fail: Fail	Overall Compliance: No
		Severity Score: 10

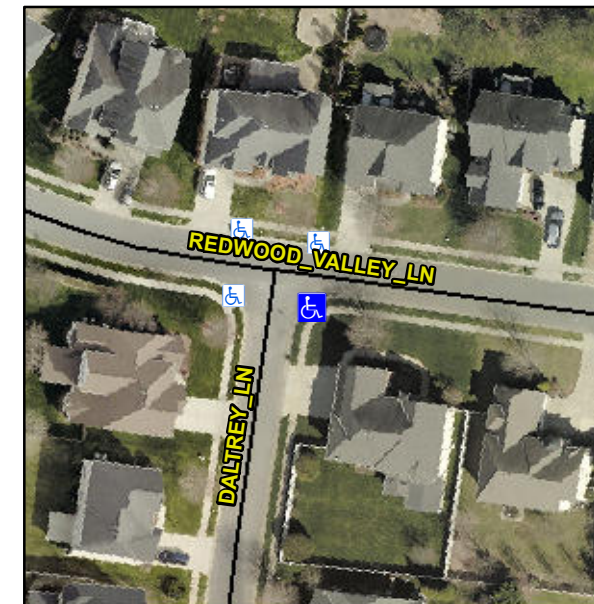
Not Found, R304.5.1, R304.5.3

Compliance	Description	Data	Compliance	Description	Data
N/A	Ramp Length (in)	48.0	Yes	Ramp Slope (%)	6.5
No	Ramp Width (in)	45.0	No	Ramp XSlope (%)	3.6
N/A	Flare Type LT	N/A	N/A	Flare Type RT	N/A
N/A	Flare Slope LT (%)	N/A	N/A	Flare Slope RT (%)	N/A
N/A	Flare Traversable LT?	N/A	N/A	Flare Traversable RT?	N/A
N/A	Landing Length (in)	N/A	N/A	DWS Provided?	N/A
N/A	Landing Width (in)	N/A	N/A	DWS Contrast?	N/A
N/A	Landing Slope (%)	N/A	N/A	DWS Length (in)	N/A
N/A	Landing X Slope (%)	N/A	N/A	DWS Full Width?	N/A
N/A	Landing Curb? (Y/N)	N/A	N/A	DWS Offset (in)	N/A
N/A	Shared Landing?	N/A			
N/A	Gutter Ponding?	N/A	N/A	Gutter Slope (%)	N/A
N/A	Gutter Lip Ht (in)	N/A	N/A	Gutter X Slope (%)	N/A
N/A	Painted X Walk1?	No	N/A	Painted X Walk2?	No
	X Walk 1 Direction	To NE		X Walk 2 Direction	To NW
N/A	X Walk 1 Width (in)	N/A	N/A	X Walk 2 Width (in)	N/A
	X Walk 1 Slope (%)	1.4		X Walk 2 Slope (%)	1.7
	X Walk 1 X Slope (%)	1.0		X Walk 2 X Slope (%)	0.1

N/A	Ramp inside XWalk1?	N/A	N/A	Ramp inside XWalk2?	N/A
	Road Slope (%)	0.8	N/A	Clear Space?	N/A
	Road X Slope (%)	0.3	N/A	Clear Space to XWalk (in)	N/A
N/A	Any Obstructions?	N/A	N/A	Storm Grate/Utility Hazard?	N/A
	Obstruction Type			Storm Grate/Utility Type	
		N/A			N/A
		Yes		Surface Condition? (G/P)	Good

Remove & Replace Curb Ramp With Two New Directional Ramps or Equivalent.
