Access Compliance Report

Public Rights-of-Way

(Curb Ramps)

Intersection ID: 28651	Main Street: MARVIN_RD	Cross Street: PRINCETON_COMMONS_DR	Location: SE
ADA ID: CB05331168E1	Ramp Type: Perp	Initial Pass/Fail: Fail	Overall Compliance: No
Severity Score: 42.5			
Codes/Mitigation Info/Possible Solution		Field Measurements/Component Compliance

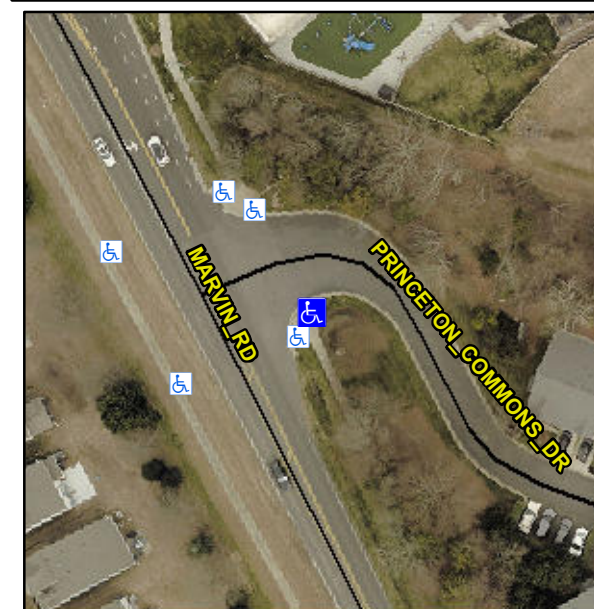
Compliance	Description	Data	Compliance	Description	Data
N/A	Ramp Length (in)	63.0	Yes	Ramp Slope (%)	5.4
No	Ramp Width (in)	33.5	No	Ramp XSlope (%)	7.9
N/A	Flare Type LT	N/A	N/A	Flare Type RT	N/A
N/A	Flare Slope LT (%)	N/A	N/A	Flare Slope RT (%)	N/A
N/A	Flare Traversable LT?	N/A	N/A	Flare Traversable RT?	N/A
N/A	Landing Length (in)	N/A	N/A	DWS Provided?	N/A
N/A	Landing Width (in)	N/A	N/A	DWS Contrast?	N/A
N/A	Landing Slope (%)	N/A	N/A	DWS Length (in)	N/A
N/A	Landing X Slope (%)	N/A	N/A	DWS Full Width?	N/A
N/A	Landing Curb? (Y/N)	N/A	N/A	DWS Offset (in)	N/A
N/A	Shared Landing?	N/A			
N/A	Gutter Ponding?	N/A	N/A	Gutter Slope (%)	N/A
N/A	Gutter Lip Ht (in)	N/A	N/A	Gutter X Slope (%)	N/A
N/A	Painted X Walk1?	No	N/A	Painted X Walk2?	N/A
	X Walk 1 Direction	To NW		X Walk 2 Direction	N/A
N/A	X Walk 1 Width (in)	N/A	N/A	X Walk 2 Width (in)	N/A
	X Walk 1 Slope (%)	1.6		X Walk 2 Slope (%)	N/A
	X Walk 1 X Slope (%)	4.7		X Walk 2 X Slope (%)	N/A

Possible Solutions:

Remove & Replace Entire Ramp.

PROW/ADA:

R304.5.1, R304.5.3

Total Cost: \$ 1850.00

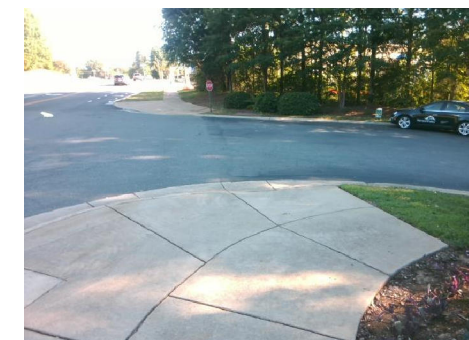
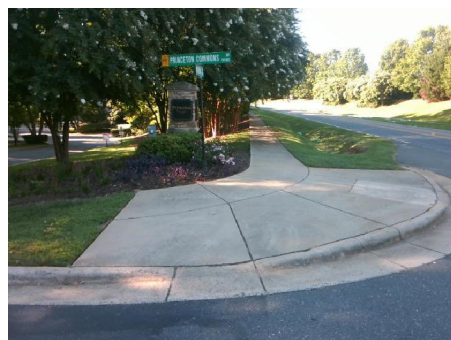
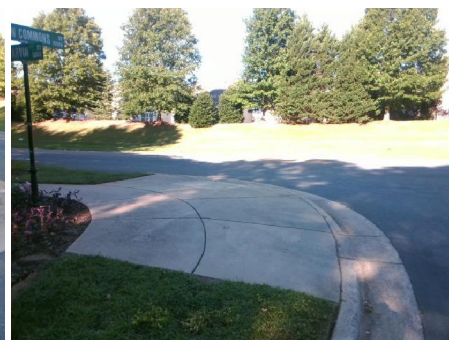
N/A	Ramp inside XWalk1?	N/A	N/A	Ramp inside XWalk2?	N/A
	Road Slope (%)	N/A	N/A	Clear Space?	N/A
	Road X Slope (%)	N/A	N/A	Clear Space to XWalk (in)	N/A
N/A	Any Obstructions?	N/A	N/A	Storm Grate/Utility Hazard?	N/A
	Obstruction Type			Storm Grate/Utility Type	
		N/A			N/A
		Yes		Surface Condition? (G/P)	Good
