# Access Compliance Report

## Public Rights-of-Way

### (Curb Ramps)

Intersection ID: 28770	Main Street: BALDWIN_HALL_DR	Cross Street: GEORGIAN_HALL_DR	Location: NW
ADA ID: CB190A32E2BC	Ramp Type: BlendTrans1	Initial Pass/Fail: Pass	Overall Compliance: No
Severity Score: 22.75			
Codes/Mitigation Info/Possible Solution		Field Measurements/Component Compliance

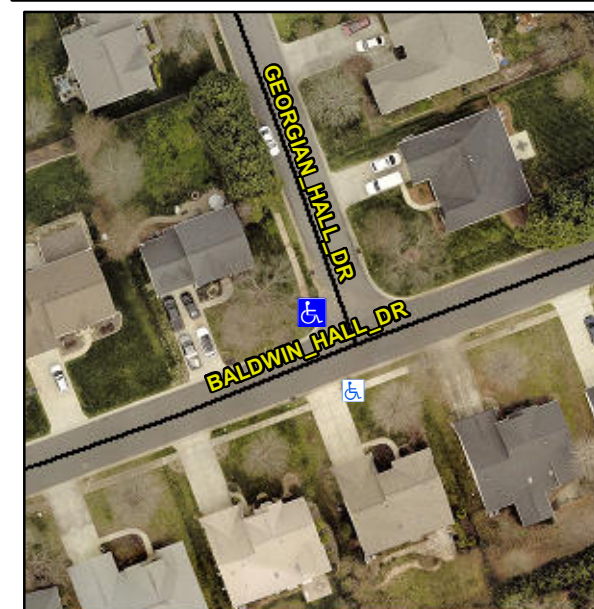
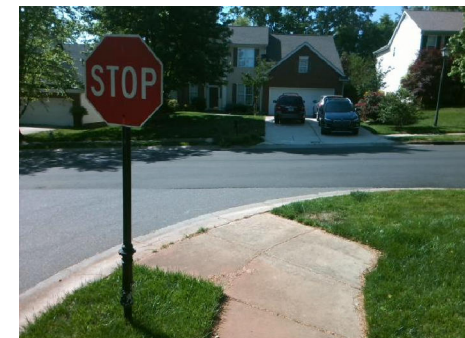
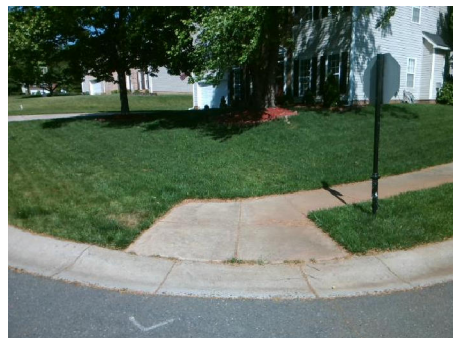
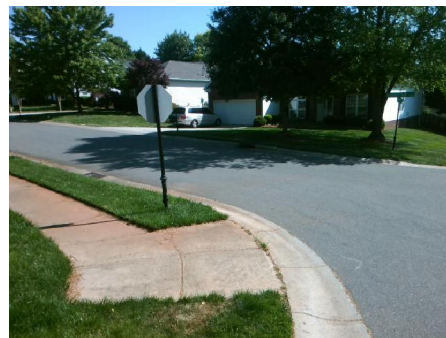
**Not Found, R305, R302.7.2, R304.5.4**

Compliance	Description	Data	Compliance	Description	Data
N/A	Ramp Length (in)	42.0	Yes	BlendTrans Slope (%)	3.9
Yes	Ramp Width (in)	51.0	Yes	BlendTrans XSlope (%)	3.3
N/A	Flare Type LT	Sloped	N/A	Flare Type RT	Sloped
N/A	Flare Slope LT (%)	7.7	N/A	Flare Slope RT (%)	1.1
N/A	Flare Traversable LT?	No	N/A	Flare Traversable RT?	No
Yes	Landing Length (in)	48.0	No	DWS Provided?	No
Yes	Landing Width (in)	51.0	N/A	DWS Contrast?	No
Yes	Landing Slope (%)	0.7	N/A	DWS Length (in)	N/A
Yes	Landing X Slope (%)	2.4	N/A	DWS Full Width?	No
N/A	Landing Curb? (Y/N)	No	N/A	DWS Offset (in)	N/A
N/A	Shared Landing?	No			
Yes	Gutter Ponding?	No	No	Gutter Slope (%)	10.1
No	Gutter Lip Ht (in)	0.5	Yes	Gutter X Slope (%)	2.4
N/A	Painted X Walk1?	No	N/A	Painted X Walk2?	N/A
	X Walk 1 Direction	To SE		X Walk 2 Direction	N/A
	X Walk 1 Width (in)	N/A		X Walk 2 Width (in)	N/A
	X Walk 1 Slope (%)	0.3		X Walk 2 Slope (%)	N/A
	X Walk 1 X Slope (%)	5.9		X Walk 2 X Slope (%)	N/A

N/A	Ramp inside XWalk1?	N/A	N/A	Ramp inside XWalk2?	N/A
	Road Slope (%)	5.9		Clear Space?	Yes
	Road X Slope (%)	0.3	N/A	Clear Space to XWalk (in)	N/A
Yes	Any Obstructions?	No	Yes	Storm Grate/Utility Hazard?	No
	Obstruction Type			Storm Grate/Utility Type	
		N/A			N/A
			Yes	Surface Condition? (G/P)	Good
			No	Curb Slope (%)	17.0

**Remove & Replace Curb Ramp With Two New Directional Ramps or Equivalent. Remove & Replace Gutter.**
