# Access Compliance Report

## Public Rights-of-Way

### (Curb Ramps)

Intersection ID: 13056	Main Street: S_MINT_ST	Cross Street: W_BLAND_ST	Location: W
ADA ID: CB2138E04146	Ramp Type: PerpDiag	Initial Pass/Fail: Fail	Overall Compliance: No
			Severity Score: 21.25

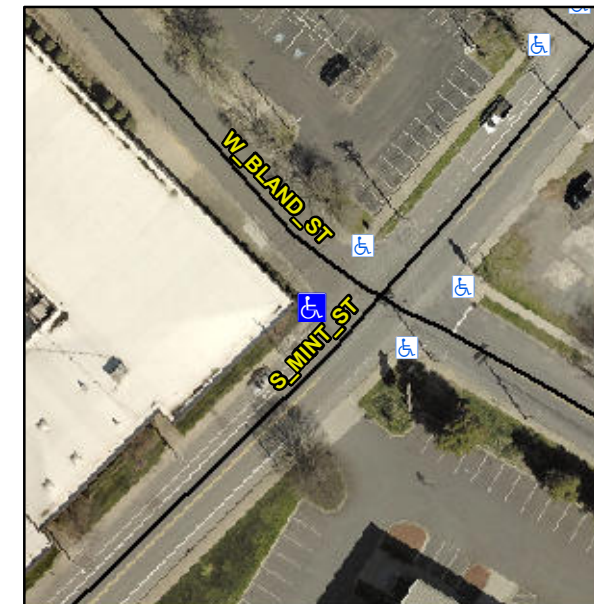
Compliance	Description	Data	Compliance	Description	Data
N/A	Ramp Length (in)	48.0	No	Ramp Slope (%)	8.8
No	Ramp Width (in)	37.0	Yes	Ramp XSlope (%)	1.5
N/A	Flare Type LT	N/A	N/A	Flare Type RT	N/A
N/A	Flare Slope LT (%)	N/A	N/A	Flare Slope RT (%)	N/A
N/A	Flare Traversable LT?	N/A	N/A	Flare Traversable RT?	N/A
N/A	Landing Length (in)	N/A	N/A	DWS Provided?	N/A
N/A	Landing Width (in)	N/A	N/A	DWS Contrast?	N/A
N/A	Landing Slope (%)	N/A	N/A	DWS Length (in)	N/A
N/A	Landing X Slope (%)	N/A	N/A	DWS Full Width?	N/A
N/A	Landing Curb? (Y/N)	N/A	N/A	DWS Offset (in)	N/A
N/A	Shared Landing?	N/A			
N/A	Gutter Ponding?	N/A	N/A	Gutter Slope (%)	N/A
N/A	Gutter Lip Ht (in)	N/A	N/A	Gutter X Slope (%)	N/A
N/A	Painted X Walk1?	No	N/A	Painted X Walk2?	No
	X Walk 1 Direction	To SE		X Walk 2 Direction	To NE
N/A	X Walk 1 Width (in)	N/A	N/A	X Walk 2 Width (in)	N/A
	X Walk 1 Slope (%)	3.8		X Walk 2 Slope (%)	1.5
	X Walk 1 X Slope (%)	0.1		X Walk 2 X Slope (%)	0.4

N/A	Ramp inside XWalk1?	N/A	N/A	Ramp inside XWalk2?	N/A
	Road Slope (%)	0.7	N/A	Clear Space?	N/A
	Road X Slope (%)	2.5	N/A	Clear Space to XWalk (in)	N/A
N/A	Any Obstructions?	N/A	N/A	Storm Grate/Utility Hazard?	N/A
	Obstruction Type			Storm Grate/Utility Type	
		N/A			N/A
			Yes	Surface Condition? (G/P)	Good

**Remove & Replace Curb Ramp With Two New Directional Ramps or Equivalent.**

**R304.5.1, R304.2.2**
